Numerical investigation of the failure of a building in Shanghai, China

Jinchun Chai^a, Shuilong Shen^{b,*}, Wenqi Ding^c, Hehua Zhu^c, John Carter^d

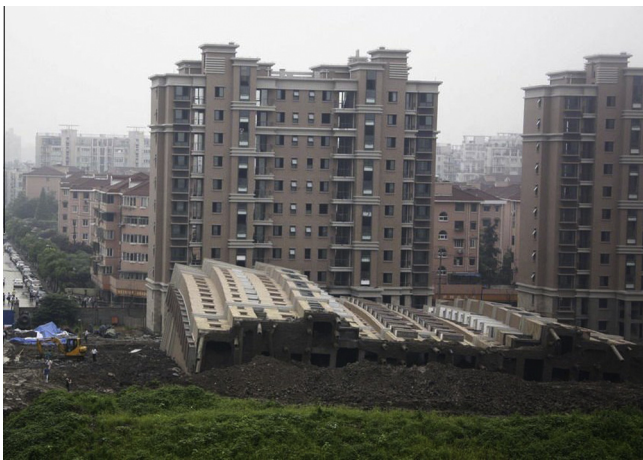
an adjacent area (Fig. 2) indicate that most if not all of the foundation piles had ruptured at about 1–3 m from the base of the foundation beam to which, presumably, they were originally attached. However, to date detail on: (1) where the failure initiated, for example by failure of the retaining structure for the excavation or the foundation piles; and (2) what was the trigger for or cause of the failure, perhaps the excavation or the dumping of the excavated soil at the northern side of the building; are not clear. In particular, what lessons geotechnical engineers can learn from this failure warrants further investigation.

Fig. 2. Overturned building.
