# On the delamination phenomenon in the repair of timber beams with steel plates

Giovanni Metelli\*, Marco Preti, Ezio Giuriani

Department of Civil, Environmental, Architectural Engineering and of Mathematics, University of Brescia, Italy

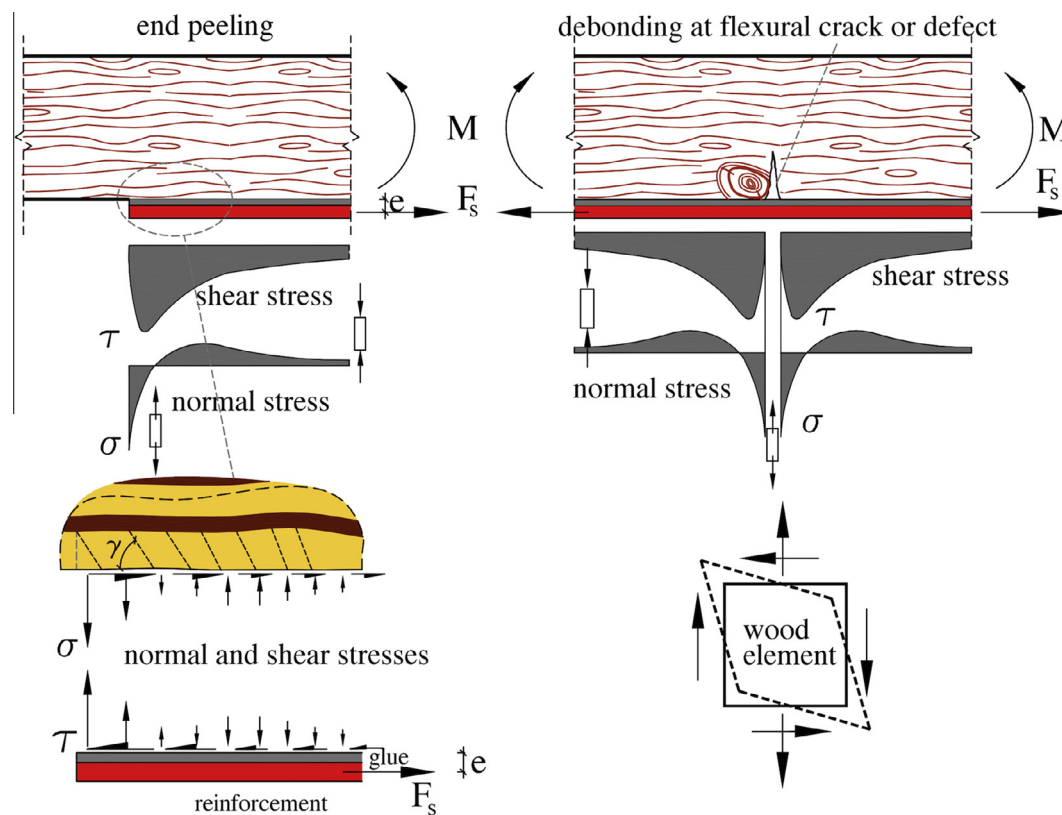
Another important issue raised by these reinforcing techniques concerns the risk of delamination, as the collaboration between the two materials – steel and timber – results in a concentration of normal and shear stresses induced by a discontinuity of one of the two elements (Fig. 1). Two brittle failure modes characterise the debonding from timber of adhesively-bonded plates: delamination might occur (i) at the cut-off point of the plate, propagating inward along the beam (end peeling) or (ii) at the toe of transversal fractures of the repaired beam and it moves toward the plate ends (midspan debonding) (Fig. 2). In recent years, these phenomena have been widely studied but specifically for reinforced concrete beams strengthened with steel plates [15,16] or with plastic reinforcements (FRP) [17,18]. These experimental studies showed that the strength and the stiffness of the beam can be substantially increased with the modulus and the amount of the applied reinforcements. However, the effectiveness of the technique may be impaired by plate delamination, which mainly depends on the characteristics of the concrete cover, shear span of the beam and on the extension of the bonded plates. Moreover, the research studies of Rahimi and Hutchinson [17] and of Sebastian [18] pointed out that the use of thin plates may encourage midspan debonding rather than end peel action in a plated beam.

Fig. 1. Stress concentration at plate ends or close to beam defects.
