## Effect of conservation treatments on heritage stone. Characterisation of decay processes in a case study

M.J. Varas-Muriel<sup>a,b,\*</sup>, E.M. Pérez-Monserrat<sup>a</sup>, C. Vázquez-Calvo<sup>a</sup>, R. Fort<sup>a</sup>

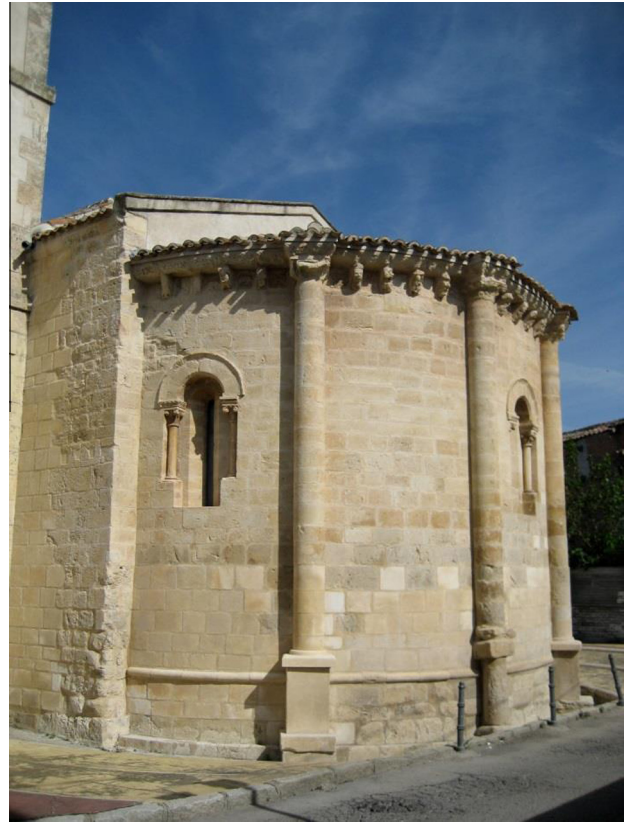
**Fig. 1.** Twelfth-thirteenth century Romanesque apse on church at Talamanca de Jarama, Madrid, Spain, whose upper stone ashlar is yellow and lower rough ashlar beige dolostone; occasional white limestone cladding. (For interpretation of the references to colour in this figure legend, the reader is referred to the web version of this article.)

The two types of dolostone were quarried from different geological strata. One, beige-coloured, compact and scantily porous, is found in the rough ashlar at the base, while the other, a yellowish and more porous stone, is found in the upper walls ashlar, including the decoratively carved modillions and cornice (Figs. 1 and 2). The former is known as *Piedra de Torrelaguna* (*Torrelaguna stone*) and the latter and more workable, *Piedra de Redueña* (*Redueña stone*) [2]. Some of the stone in the dado and underneath the modillions was replaced (possibly in the 1885 intervention) with the same varieties of dolostone as the original material. The lighter tone cladding visible in the same areas was laid during the 1990 restoration (Fig. 1).
