Causes and controls of cracking at bridge deck overlay with very-early strength latex-modified concrete

Kyong-Ku Yun^a, Pangil Choi^{b,*}

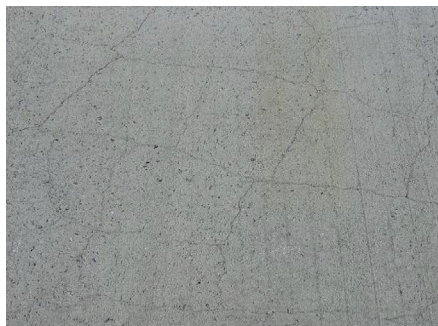
(a) VES-LMC Overlay in Korea

Fig. 1(a) shows an example of a map cracking, which took place at a typical pattern on a bridge overlaid with VES-LMC in Korea. Fig. 1(b) shows the map cracking at Braddock Road Bridge of Route 620 of Virginia in the United States, which is one of the very first overlays by RS-LMC (Rapid Setting Latex Modified Concrete) in the USA [5]. The surface of the bridge is grooved, and it is deemed that it was overlaid by an inexperienced constructor during the initial application of the RSLMC, causing severe cracking. However, it has no debonding and/or pop-out. Such problems as inadequate bonding with the repairing body, the quality of the concrete during its procurement, and poor curing condition can cause the map cracking.

Map cracks were not found the first day after placement of the VES-LMC but after three to seven days were visible on the surface of the overlay, having a multi-direction pattern of fine cracks that did not penetrate much below the surface and were usually a cosmetic problem only. They were difficult to see, except when the surface had been wet and then allowed to dry; the fine cracks were visible until they dried. Map cracks were found where the overlay had been improperly tined and near expansion joints.

Map cracks could be a kind of plastic shrinkage cracking which develops when water evaporates from the surface of freshly placed

concrete faster than it is replaced by bleed water. Due to the restraint provided by the concrete below the drying surface layer, tensile stresses develop in the weak, stiffening plastic concrete, resulting in shallow cracks of varying depth [6].
