Fracture of reinforcing steels in concrete damaged by ASR

Toyo Miyagawa*

Dept. of Civil & Earth Resources Eng., Kyoto University, Nishikyo, Kyoto 615-8540, Japan

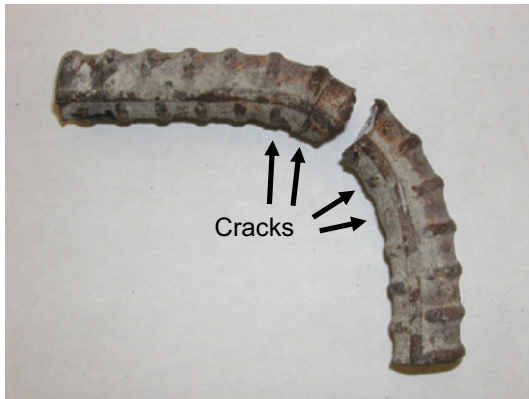
All reinforcing steel samples were found to have corrosion in the bent section. In the Kansai area of Japan, sea sand contaminated with chloride had been used as fine aggregate for concrete. Fracture occurred at the bends, and cracks initiated at the bases of the ribs on the inside radius (Fig. 1). The cracked or fractured reinforcing steels had smaller radii of base curvature of the rib than those on the currently marketed products. The fracture surface was flat with very little plastic deformation as shown in Fig. 2, where cleavage and quasi-cleavage cracks which were evidence of brittle failure were predominant (Figs. 3–5). The only exception was the shear lip where ductile fracture surface was found (Fig. 6). Concrete materials such as Ca and Si were detected at the crack initiating point as shown in Fig. 3, suggesting that these cracks were already present at the time of concrete placing. Work hardening at the bend was confirmed by the hardness increases in the inside and outside of the bend. The inside and outside hardness values were about 50–80 (HV10) higher than those at the center of the bend or about 90 (HV10) higher than those in the straight part.

Fig. 1. A fractured reinforcing steel.

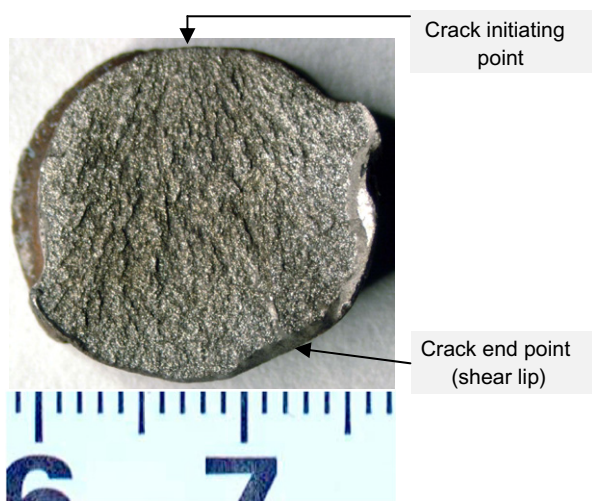
Fig. 2. Macro-view of the fracture surface.

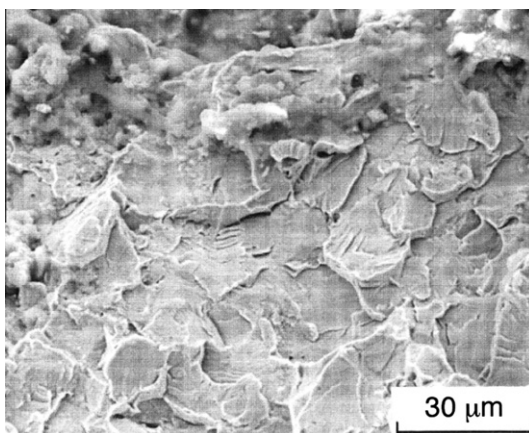
Fig. 3. Crack initiating point before pickling (cement hydrates are present).

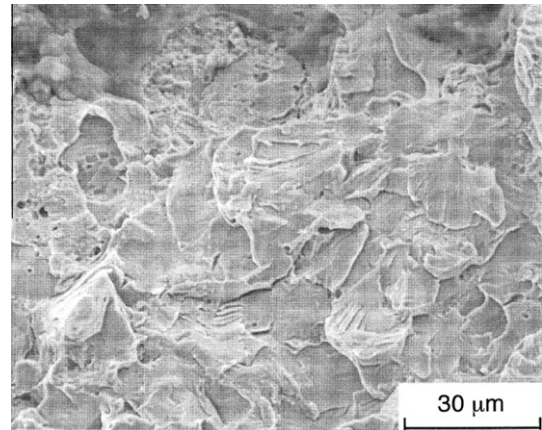
Fig. 4. Fracture surface near the crack initiating point after pickling.

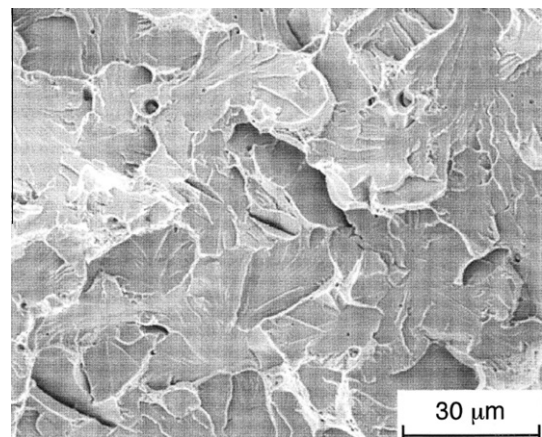
Fig. 5. Fracture surface about 12 mm inside from the crack initiating point.

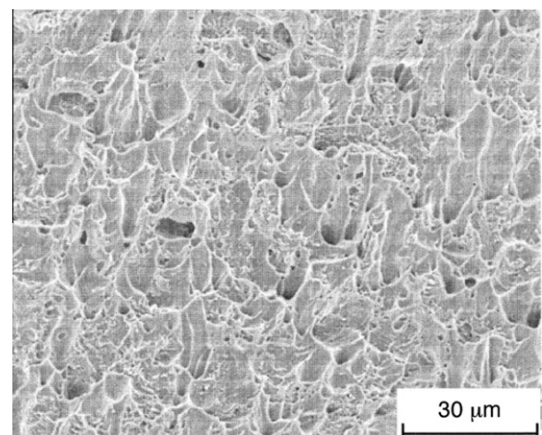
Fig. 6. Fracture surface of the shear lip.
