# Investigation on the behaviour of a restoration plaster applied on heavy salt loaded masonry

Barbara Lubelli <sup>a,b,\*</sup>, Rob P.J. van Hees <sup>a,b</sup>, Caspar W.P. Groot <sup>a</sup>

The present paper reports the results of a series of investigations and monitoring performed, during a period of more than three years, on an ancient church flooded by the sea 50 years ago. This building can be considered representative for many other brick-masonry monuments in the flooded areas in the Netherlands. The church, restored several times in the past 50 years, shows a serious decay mainly affecting the restoration plaster applied in the interior; the damage appeared few years after the application of the plaster and has considerably increased in time.

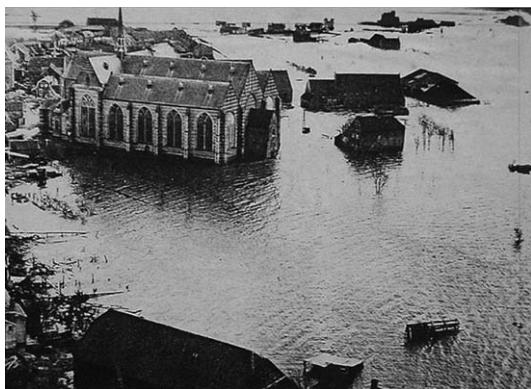
In 1953, due to the flooding, the church was submerged in the seawater up to the window sills (Fig. 1). Because of the wall being saturated with seawater during the flooding, a serious decay developed when the masonry dried out. The church required an extensive restoration of the interiors that was completed only in 1963: a tar like layer was applied on the brick walls and on this a plaster was applied. The aim of the application of the tar layer was to keep the salt inside the masonry. The tar layer, being not permeable, avoids the liquid water transport, and therefore the salt transport from the masonry to the plaster. Due to detachment of this plaster occurring after several years from the application, a new restoration was necessary (1991–1994): in this occasion the plaster and the tar layer were removed and a new plaster was applied. This new plaster is a ready-to-use cement based restoration plaster for salt loaded substrates, and should transport the salts from the substrate to the surface of the plaster where they should crystallize without producing any damage. When the monitoring started and the first investigations took place (July 2000), the plaster already showed a serious decay that considerably increased in the following three years.

Fig. 1. The church submerged in sea-water during the flooding in 1953.

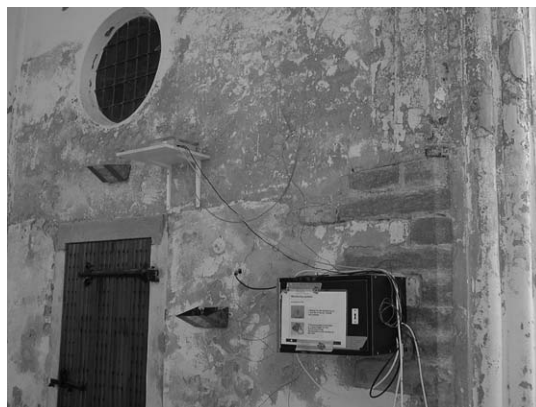
The damage of the plaster is mainly located up to 4 m from the ground level, and is particularly serious on the walls (Fig. 2) and the columns of the choir. The damage appears at the beginning as peeling of the paint layer and formation of cracks and increases then with sanding and crumbling of the plaster. This development of the decay seems to be typical of this type of plaster, if applied in very severe situations and it has been observed on several occasions [2]. In some spots in the church the plaster layer is completely weathered and the brick substrate starts decaying. Efflorescences are visible on the plaster and on the substrate during periods of low RH.

Fig. 2. South wall of the choir showing serious damage.
