# A rehabilitation study of sandwich GRC facade panels

João R. Correia <sup>\*</sup>, João Ferreira <sup>1</sup>, Fernando A. Branco <sup>2</sup>

Glass fibre-reinforced concrete (GRC) has been used for more than 30 years in the construction industry, especially in facade panels. In this paper, a rehabilitation case study is presented, of a building where cracking and excessive deformations were detected in the sandwich GRC facade panels due to thermal effects. The structural behaviour of the panels was simulated with a finite element method (FEM) model, validated by experimental tests performed on the facade, and then used to assess the efficiency of a repair technique, based on external insulation, which showed a good efficiency.

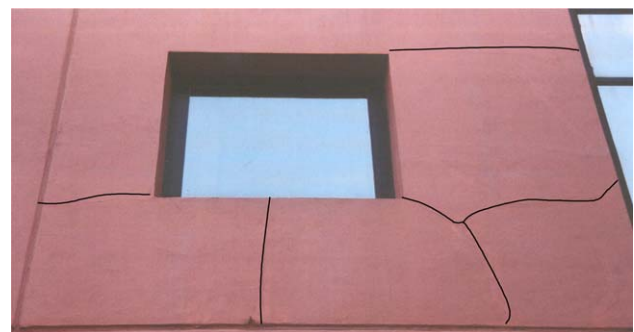
The main defect detected in the facade panels consisted of extensive cracking with the following pattern: horizontal or vertical cracks near the window corners, coinciding with the GRC laminas (Fig. 3); vertical and horizontal cracks mainly in the upper zones of the panels; these cracks' openings are less than 1 mm and completely cross the GRC sheet thickness (Fig. 4).

Fig. 3. Cracking pattern in the facade panels.
