Base geometry influence on impact load failure of a traffic signal pole

Min Ook Kim, Amanda C. Bordelon*, Uma Ramasamy, Chris P. Pantelides

Civil and Environmental Engineering, University of Utah, 110 Central Campus Drive, Salt Lake City, UT 84112, USA

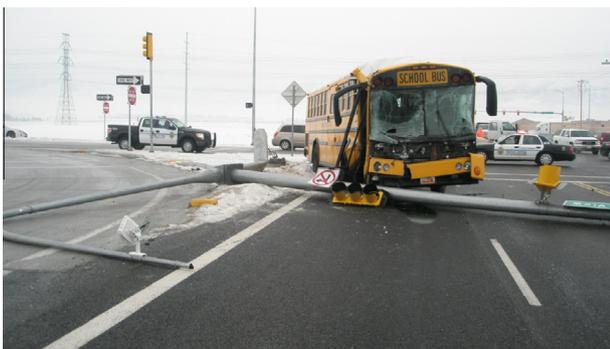
Fig. 1 shows the condition of the traffic signal pole and bus after the incident. The pole was located on a curbed median at the intersection of a major arterial highway and a secondary highway. The pole has been constructed recently so operational life and fatigue damage were not an issue. This incident occurred on a cold day with an air temperature of $-9.4\text{ }^{\circ}\text{C}$ and possible patches of ice on the road surface. The region was below freezing temperatures for over 24 h. The mass of the bus was 12,917 kg, which is significantly larger than standard impact crash vehicles used to test existing break-away structures [16,17]. The posted speed limit at this location is 89 km/h. The bus driver stated that he initially was going to make a right turn, but changed his mind, lost control and then slid into the concrete curb and hit the pole. As shown in Fig. 1, it was expected that the impact first occurred on the right passenger-side and the front of the bus.

Fig. 1. Photo taken after incident showing the condition of the traffic signal pole and bus.

thickness near the base, due to the inner welded back-up ring, likely caused a stress concentration and led to the specific shear failure location 50 mm from the bottom. The back-up ring and the pole geometry are investigated in the finite element model in order to understand their influence on the failure location and deformation expected in a similar impact load scenario.
