# Safety analysis of modern heritage masonry buildings: Box-buildings in Recife, Brazil

Box-buildings are structural masonry buildings named as such because of their shape. There are around 5000 of them in Recife, Brazil. This paper presents a safety analysis of one box-building that suffered collapse on December 2007. The research aims at quantifying the safety of this type of existing buildings and at better understanding their structural behavior to try to identify the reasons for the collapse. A finite element model was prepared and a set of nonlinear numerical analyses were performed. The results of the analyses show good agreement between the observed damage in the real building and the damage achieved numerically at the current condition ( $LF = 1$ ). The model thus seems to represent satisfactorily the real behavior of the building but the safety factor obtained seems too conservative and does not justify the collapse observed in reality. Since results show that the building should not have failed under normal working conditions, a collapse assessment about why the building fell is therefore provided and a sensitivity analysis was performed in order to understand the impor

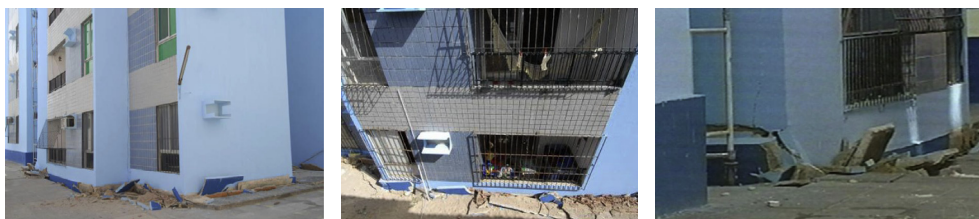
The research is focused on one of the box-buildings of the residential complex *Sevilha*, in *Jaboatão dos Guarapes*, within the RMR. The residential complex is composed by four blocks of very similar characteristics. Block B partially collapsed on December 2007 and it was later demolished. Fig. 1 shows the building after the collapse. Failure of the foundation masonry walls was observed. This collapse triggered the experimental and numerical research carried out by de Carvalho [8]. The visual inspection and testing program described next was performed on the block C of the complex.

Fig. 1. Views of the building after the collapse.
