Investigations into the corrosive environments contributing to premature failure of Australian coal mine rock bolts

Craig P.^{a,*}, Serkan S.^a, Hagan P.^a, Hebblewhite B.^a, Vandermaat D.^a, Crosky A.^b, Elias E.^b

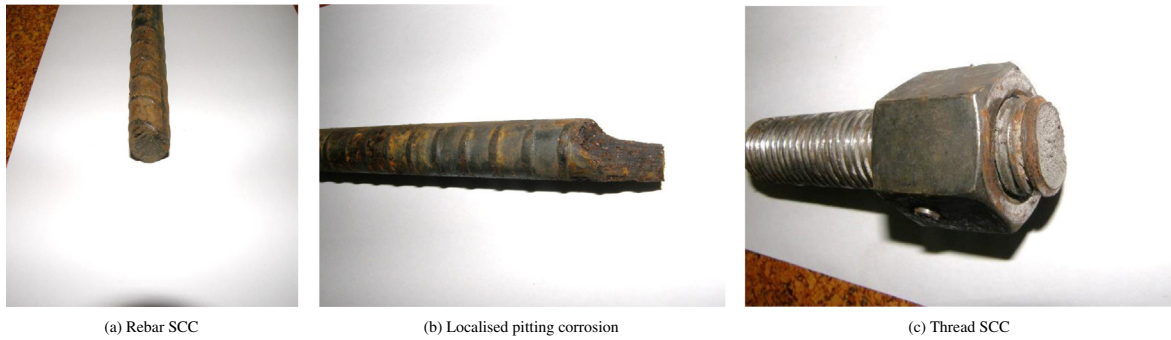
Fig. 1. Three types of rockbolt corrosion fracture surfaces.

shown in Fig. 1. Rebar SCC represented 63% of the broken bolts, localized pitting corrosion represented 30% and thread SCC was 7%. It was obvious from mine sites with an adequate number of samples that both SCC and localized pitting corrosion occur within the same environments. Two mines, Mine 1 and Mine 3, represented 83% of the broken bolts and underground surveys were conducted to further define the extent of the problem.

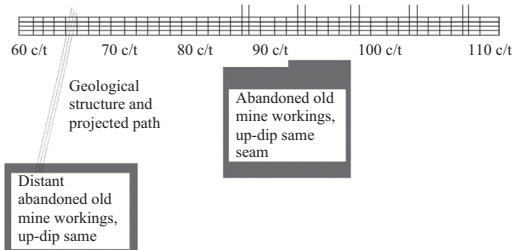
Mine 1 represented 20% of the bolts within the broken bolt database at UNSW Australia. The portion of main roadways visually inspected for broken bolts is schematically shown in Fig. 2 with respect to some major features. The support pattern included 2.1 m rock bolts and a mixture of 4 and 8 m long cable bolts. The right hand side of the main roadways was known to contain the majority of broken bolts, and heading #5 was known to have water dripping from many of the roof and cable bolts. A total of 226 broken bolts were discovered, with the higher stress cut-throughs accounting for 60% of the broken bolts and heading #5 on the far right accounting for 30% of the broken bolts. Horizontal stresses are typically most concentrated at the edge of the roadway, and this bolt location accounted for 95% of the broken bolts even when the roof showed very little visual deformation or plate loading on the bolts.

Fig. 2. Schematic Mine 1 main roadways and associated features.

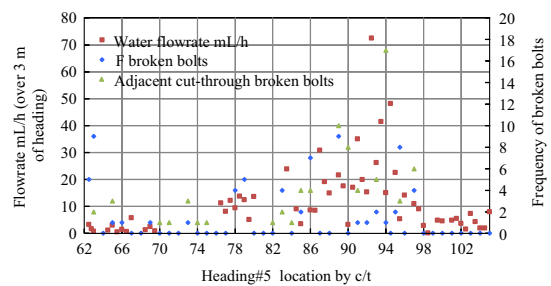
To obtain groundwater flow rate trends, each bolt/cable with water flowing (dripper) had flow measured at every intersection and mid-pillar over a selected 3 m length of roadway and then added together. The flow rate and frequency of broken bolts is plotted in Fig. 3 showing a good correlation between groundwater flow rate in heading #5 and the number of broken bolts, especially in the cut-throughs (c/t). With reference to Fig. 2, the higher flow rates measured between 85–95 c/t coincide with the proximity of the abandoned flooded old mine workings some 200 m away up-dip within the seam. Resin capsule length used with the roof bolts

Fig. 3. Mine 1 survey of broken bolts and dripper flow rates.
