Case Report

Two loose screws: near-miss fall of a morbidly obese patient after an operating room table failure[☆]

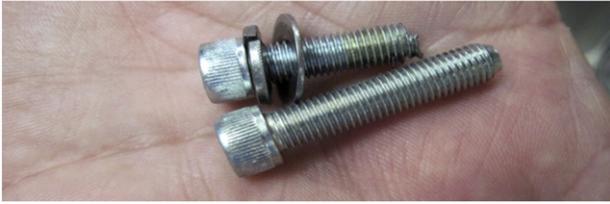
Fig. 1 One of the broken bolts (top) of the tilt cylinder mechanism compared to an intact bolt (bottom).

The Steris 3080 OR table (Steris Corporation, Mentor, OH) was disassembled to find that the 2 bolts fastening the tilt cylinder bracket to the table's base had sheared in half (Fig. 1). The tilt cylinder bracket connects an actuating arm, which manipulates the OR table laterally in an "airplane" tilt fashion, to the table's base (Fig. 2). When both bolts failed, the bracket broke free from the base causing the OR table to abruptly and steeply rotate to the left. Per our institution's OR table maintenance policy, all OR tables are checked and serviced semiannually. According to the head of our institution's biomedical engineering department, in the nearly 2 decades, these or similar OR tables have been used, there have been approximately 1 dozen instances where, during routine scheduled maintenance, 1 bolt was found to be incompetent, while the other was intact. Interestingly, when 1 bolt fails, there is some play in the

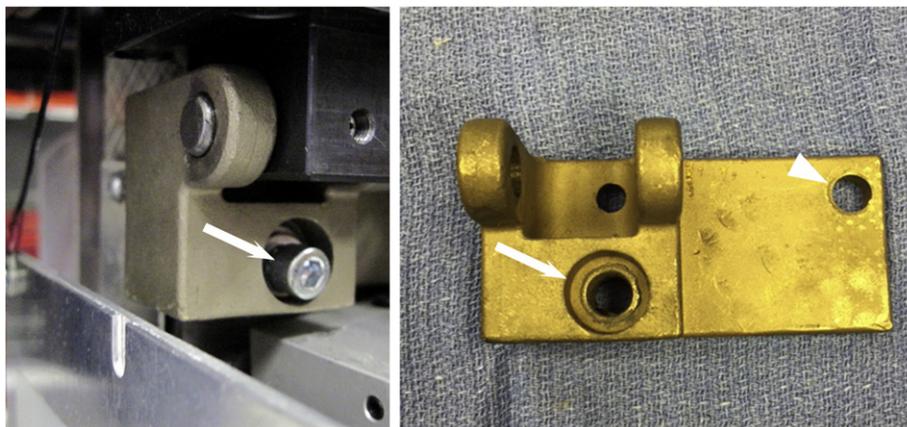
Fig. 2 The tilt cylinder mechanism bracket of the OR table, as seen after removal of the OR table pedestal covering. The photo on the left shows the bracket bolted in place. The picture on the right shows the bracket removed from the OR table pedestal. The arrow points to the location of the larger bolt. The arrowhead points to the location of the second bolt, which is visible on the right, but out of the picture on the left.
