Case Report

Riata lead failure presenting as a life-threatening electrical storm: A novel manifestation of electrical lead failure

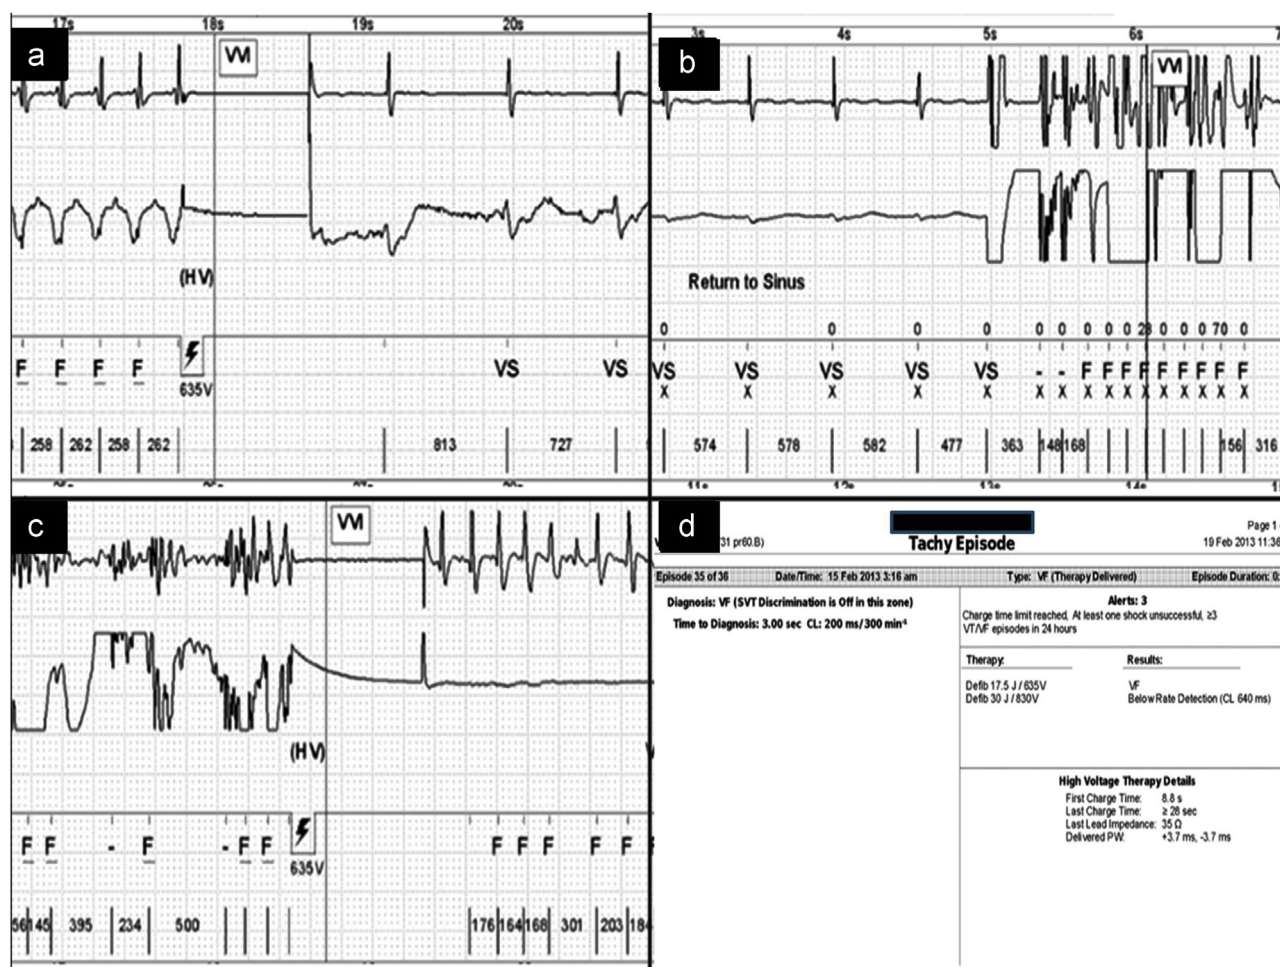
Intracardiac electrograms were examined and they revealed that a total of 36 shocks had been delivered to the patient (Fig. 1). The first appropriate successful shock delivered 17.5 J for VF (Fig. 1a). The ICD was programmed to 2 ventricular tachycardia (VT) zones (VT1 < 360 ms, VT2 < 320 ms) and a VF zone (< 280 ms). After the first successful shock, noise was detected, which was classified as VF resulting in an inappropriate shock (Figs. 1b and c). Repeated inappropriate shocks, delivered in response to noise, resulted in VT. This in turn resulted in further shocks, finally degenerating to VF (Fig. 1c).

Fig. 1. Intracardiac electrograms. (a) Regular tachycardia at 260 ms was binned as fibrillatory complexes and reverted to sinus rhythm after a high voltage shock. (b) Noise in sinus rhythm was binned as fibrillatory complexes. (c) Inappropriate shock, delivered in response to noise, initiates ventricular fibrillation. (d) Episode summary 35: showing a prolonged charge time (> 28 s). F, fibrillatory complexes; VS, sinus rhythm; HV, high voltage shock; VT, ventricular tachycardia; and VF, ventricular fibrillation.
