Case Report

Shock-induced failure of a Riata lead with normal electrical lead parameters and a normal fluoroscopic appearance: A case report

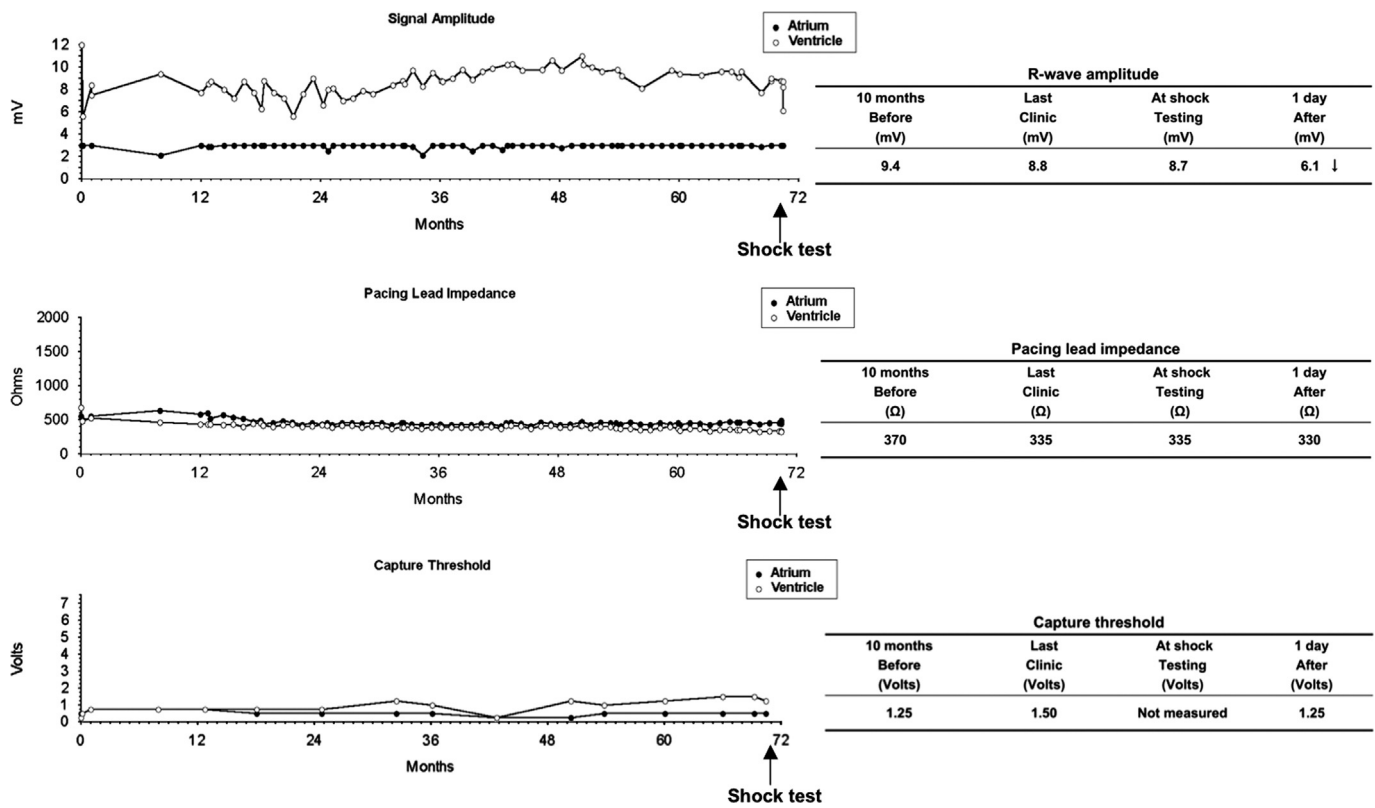
Fig. 1. Serial electrical lead parameters are shown (upper, R-wave amplitude; middle, pacing lead impedance; bottom, capture threshold). All routine device interrogations in the outpatient clinic had been within normal range, with sensing amplitude 8.7–9.4 mV, pacing lead impedance 335–370 Ω , and capture threshold 1.25–1.5 V/1.0 ms over the preceding 10 months. After shock testing, intra-cardiac R-wave amplitudes abruptly decreased despite stable pacing impedance and capture threshold.

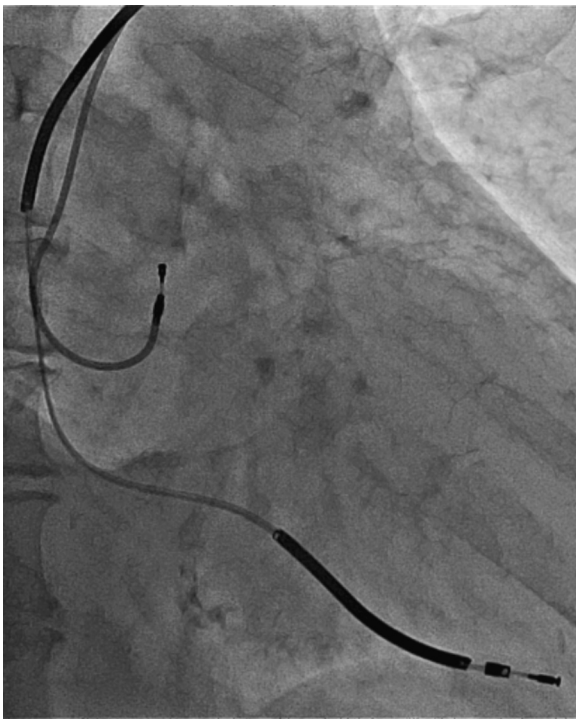
Fig. 2. Cine-fluoroscopy showed no fluoroscopic evidence of cable extrusion between the proximal and distal coils, as with other portions of the lead.

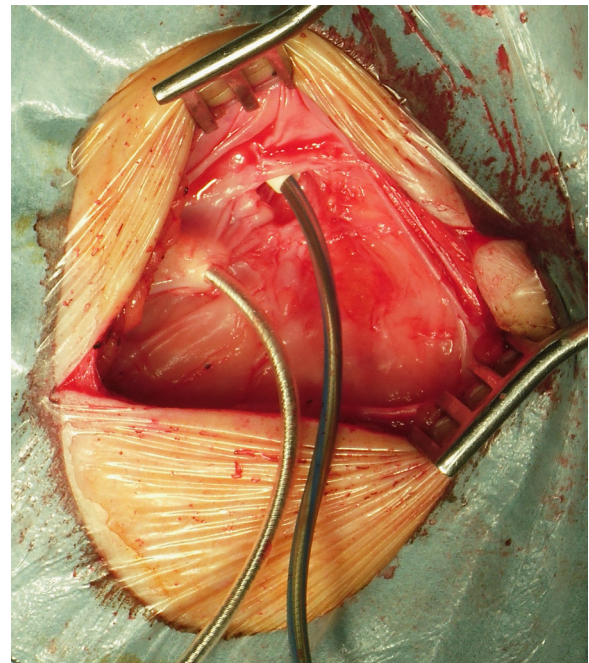
Fig. 3. No charring was apparent in the pocket area.

inducing VF to see if it would unmask a potential insulation defect. After the first delivery, the device declared "possible output circuit damage." Subsequent shock could not be delivered owing to a fault in the pulse generator or lead. High-voltage lead impedance was consistently below 20 Ω , suggesting post-shock development of high-voltage cable abrasion. On the following day, the patient
