Effect of human error on the reliability of roof panel under uplift wind pressure

H.P. Hong*, W.X. He

Department of Civil and Environmental Engineering, University of Western Ontario, London, Ontario N6A 5B9, Canada

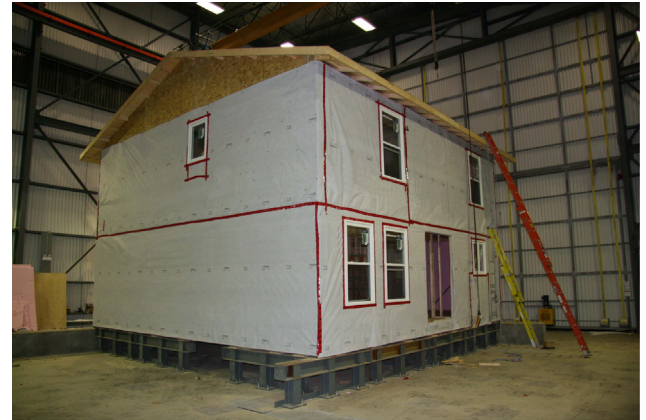
(a) Full scale test house during construction (processed to avoid commercial contains)

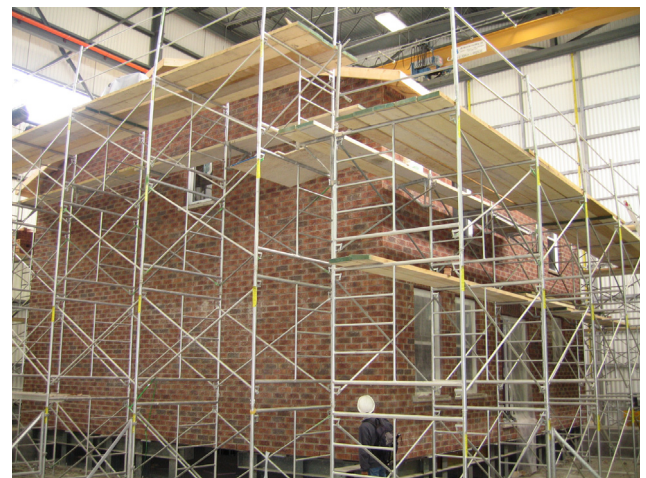
(b) Full scale house after installing brick veneer walls.
