Hard rock TBM tunneling in challenging ground: Developments and lessons learned from the field

Lok Home

The Robbins Company, Solon, OH, USA

2.1. Turkey's Kargi Kizilirmak Hydroelectric Project

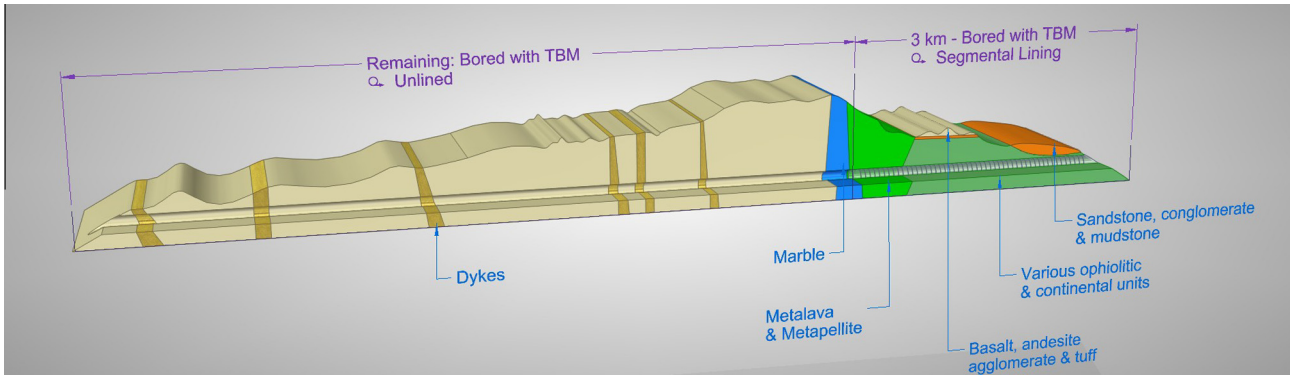
Fig. 1. Original plan of excavation and expected geology.

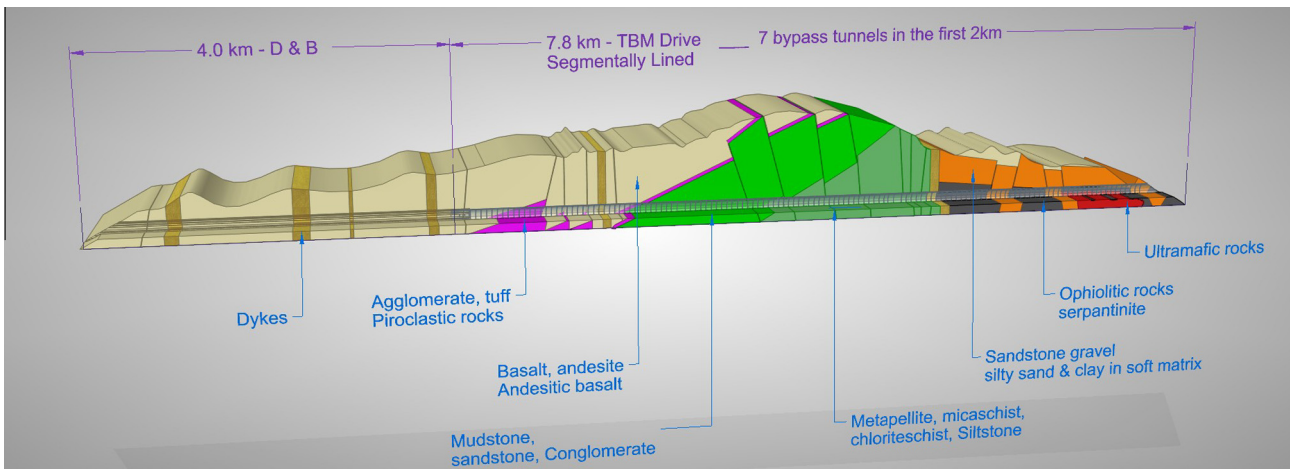
Fig. 2. Geology and outcome of tunneling works at 50% complete.

These hopes were proved wrong, however, as six more bypass tunnels were needed within the first 2 km of tunneling. At this point it became apparent that the actual geology was far more complex than originally stated. Both the contractor and manufacturer worked together to develop and improve bypass tunneling and hand tunneling techniques, resulting in an average bypass tunnel construction time of just 14 days. All tunnels were completed safely and in a timely manner, though there were of course significant delays associated with the downtime. Despite the setbacks of these multiple events, the TBM did succeed in crossing numerous faulted sections that would have trapped a machine with less power. In fact, the crew measured cavity heights above the cutterhead in some of these fault zones at over 30 m.

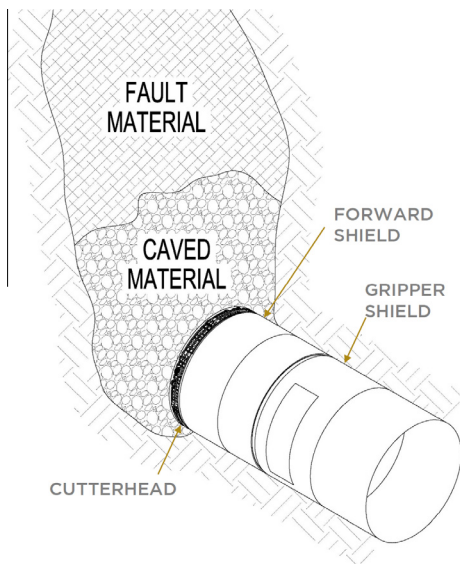
The Kargi TBM was launched in early 2012. The machine almost immediately encountered geology that was substantially more problematic than was described in the geological reports. The geology consisted of blocky rock, sand, clays, and water bearing zones. This ground still allowed the possibility to retract the cutterhead if needed, to restart the TBM if it became stuck. However, after boring 80 m the TBM became stuck in a section of collapsed ground that extended more than 10 m above the crown, loaded onto and around the cutterhead. As a countermeasure that was immediately put into place to avoid the cutterhead becoming stuck in the blocky material, crews began boring half strokes and half resets (see Fig. 3).

Even with these measures, the machine encountered a section of extremely loose running ground with high clay content. A collapse occurred in front of the cutterhead and the cathedral effect resulted in a cavity forming that extended more than 10 m above

Fig. 3. TBM encountering fault zones at Kargi.

the crown of the tunnel. The weight of the collapsed material trapped the cutterhead. After several unsuccessful attempts to clean out and restart the cutterhead, consolidation of the ground above and in front of the machine was carried out. Injection of polyurethane resins via lances inserted through the cutter

housings and muck buckets was the method utilized for consolidation operations; however, injection locations were restricted to the available openings and subsequent attempts to restart the cutterhead proved to be unsuccessful.

After assessing all the available options it was decided that a bypass tunnel would be required. Robbins Field Service assisted Gülermak with bypass tunnel design and work procedures to free the cutterhead and stabilize the disturbed ground. Blasting techniques were ruled out due to concern over further collapses caused by blast induced vibration; hence, the excavation was undertaken using pneumatic hand-held breakers. Bypass tunneling was successfully completed and at that point the section of bad ground was believed to be an isolated one.
