Case Report

Metallosis following a dual coat porous hydroxyapatite shoulder hemiarthroplasty

Humza Khan*, Mark Hurworth, Alan Kop

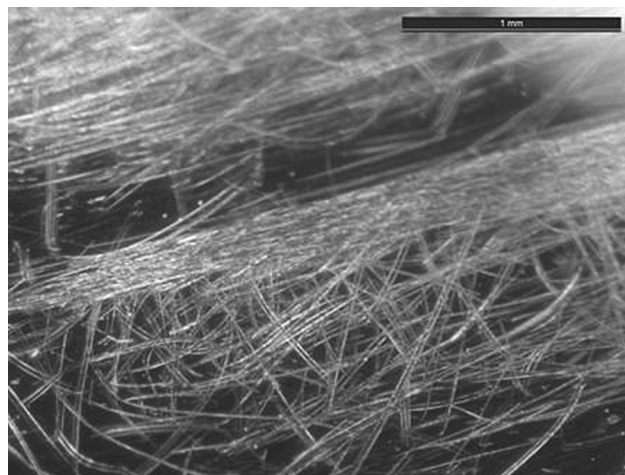
Fig. 2 – DuoFix Shoulder Multidirectional scratching.

Macro analysis using a Leica MZ6 stereomicroscope revealed good bony ingrowth with geometrically diverse spicules of bone; however also noted was metallic stained tissue peripherally. Minor remnant HA coating was observed. The bearing surface showed fine scratching and scouring over most of the surface with a small unworn region towards the edge of the device as shown in Fig. 2.

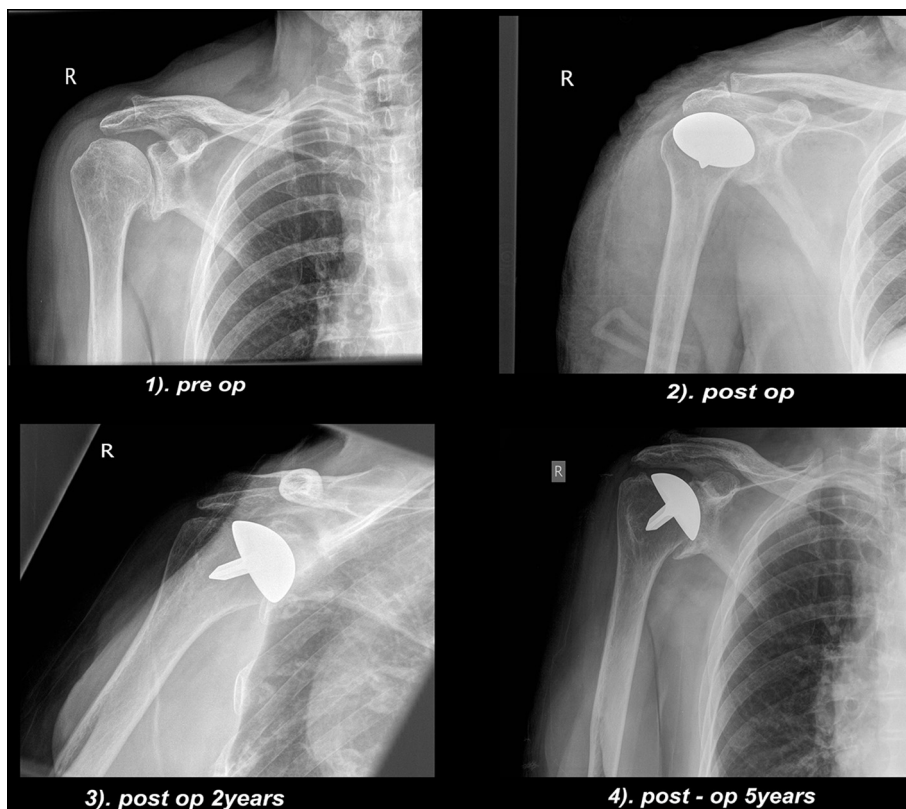
After five years she was referred for further opinion and management of her right shoulder pain. She reported discomfort and reduced range of movement. Radiographs, a CT scan and blood tests were performed to further investigate the shoulder. These tests revealed superior subluxation of the humeral component with respect to the glenoid and a normal white cell count [Fig. 1].

Fig. 1 – X-ray progression.

Revision to a reverse shoulder arthroplasty was carried out in 2013 using the DePuy DELTA Xtend shoulder system. The primary intra-operative finding was tissue staining consistent with significant metallosis. There was surrounding inflammatory and granulomatous tissue. The prosthesis was still fixed. The remainder of the procedure was conducted without complication. The retrieved implant was sent for analysis to the Biomaterial Laboratory at Royal Perth Hospital following standard retrieval protocols.
