Swelling of safety rod guide tubes in nonuniform fields of temperature and irradiation

S.I. Porollo^a, Yu.V. Konobeev^a, F.A. Garner^{b,c,*}

Abstract

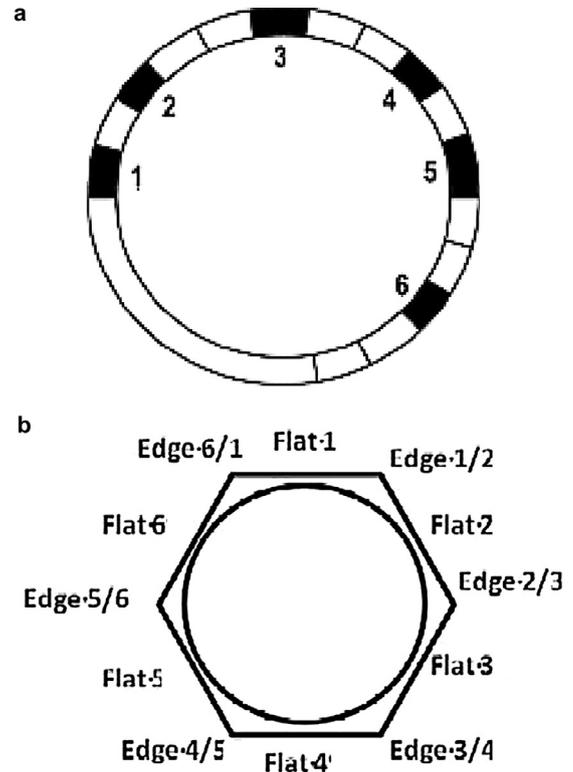
To measure the swelling of the temperature compensator material, specimens of 55mm×10mm×4 mm in size were cut out for five cross-sections along the core height. The cutting scheme and specimen numbering for each section are shown in Figure 1. Swelling was determined for six elevations varying from -500 to +500 mm using the Archimedes

Fig. 1. (a) Cutting scheme for specimens used for measuring the material density of reactor BN-350 temperature compensator. This scheme was used for six separate elevations from -500 to +500 mm from core midplane. (b) Designations of corners and flats for the BOR-60 guide tube.

The density of the BOR-60 safety rod guide tube was measured using specimens of 3-5 g in weight cut from flat middles at nine elevations on flat 2, which was chosen because of its notable dimensional change behavior. The distance between three sets of opposing corner edges was measured at each of three elevations, picking the two corners that bound flat 2, and another opposite corner between flats 4 and 5.
