Analysis of damaged welds no. 111 in the PGV-1000 steam generator and damage repair proposals

V.P. Povarov*

Novovoronezh NPP, a Branch Department of JSC "Rosenergoatom Concern". 396072, Novovoronezh, Voronezh Region, Yuzhnaya 1 industrial estate, Russia

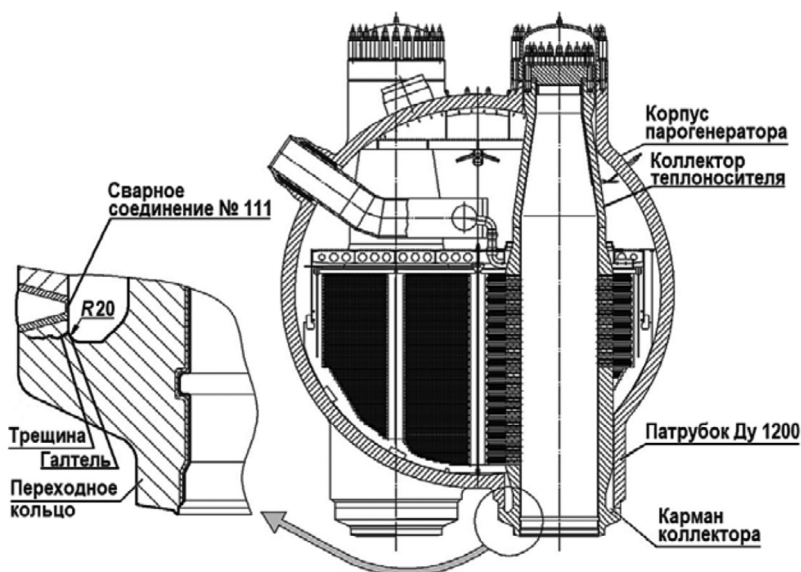
Fig. 1. PGV-1000 M steam generator.

The reliability of the VVER-1000 NPP's main equipment, specifically in conditions of an extended service life, depends on the reliability of its individual components. The most critical item for the VVER-1000 steam generators (SG) is the welded joint between the primary coolant "hot" header and the steam generator vessel's Dn1200 nozzle (Fig. 1).

Сварное соединение № 111 = Welded joint 111
 Корпус парогенератора = Steam generator vessel
 Коллектор теплоносителя = Coolant header
 Трещина = Crack
 Галтель = Fillet
 Переходное кольцо = Adapter ring
 Патрубок Дн 1200 = Dn1200 nozzle
 Карман коллектора = Headerpocket
