Gross Trunnion Failure After Primary Total Hip Arthroplasty

Samik Banerjee, MD, Jeffrey J. Cherian, DO, James V. Bono, MD, Steven M. Kurtz, PHD, Rudolph Geesink, MD, R. Michael Meneghini, MD, Ronald E. Delanois, MD, Michael A. Mont, MD

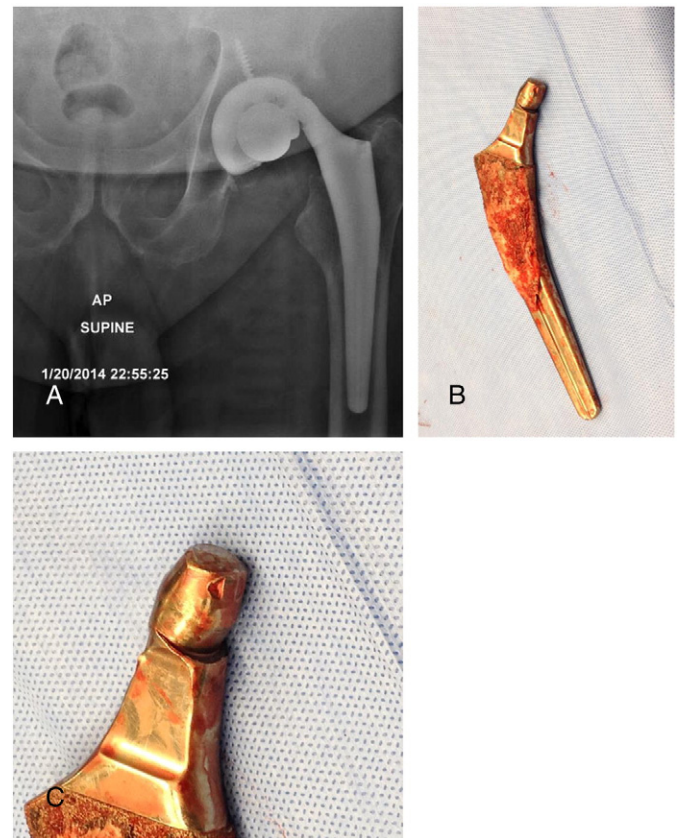
However, 8 years later, he presented to the office complaining of marked acute onset of non-radiating left hip and groin pain while getting in to his car. He was unable to bear any weight thereafter. Radiographs revealed disassociation of the trunnion from the femoral head component and it was indicated for exploration/revision surgery (See Fig. 1A). Metal ion levels performed prior to revision surgery were found and revealed a cobalt ion level of 0.5 ng/L and chromium of 2.9 ng/L. Intra-operatively, the trunnion was found to be malformed with wear of the antero-superior and postero-superior surface and grooving of the inferior surface (See Fig. 1B and C). Minimal peripheral osteolysis was found around the acetabulum and proximal femur on

Fig. 1. (A), (B), and (C) Initial radiographic images on presentation (patient 1) showing dissociation of the trunnion from the femoral head, and explanted femoral stem demonstrating gross trunnion failure.

exploration. In addition, there was substantial black debris suggestive of metallosis in the periprosthetic tissues. The proximal femoral lysis created some erosion and thinning of the medial calcar, as well as the superior acetabulum in the periphery. During revision, the acetabular shell was retained while the liner and the femoral stem were replaced with a revision stem ceramic head, and a highly crosslinked polyethylene liner. His post-operative course was uneventful and he has returned to his usual activities including playing golf 4–5 times a week at 5 months follow-up.
