The Journal of Arthroplasty

Fatigue Fracture in Dual Modular Revision Total Hip Arthroplasty Stems Failure Analysis and Computed Tomography Diagnostics in Two Cases

We report on two patients with fracture of a modular, tapered and distally fixed, uncemented titanium revision hip stem, not previously described. A failure analysis revealed that the cause of the fractures was the development of fatigue cracks in the mid-stem cobalt–chromium modular junction ending in corrosion-fatigue failure. No material defects or stress risers were found in any of the implants. The diameter of the mid-stem modular junction might be undersized for use in heavy and active patients. We also report a new way of detecting an undisplaced fracture at the modular junction, using the scout image from a computed tomography (CT) scan; a technique that can be used when plain radiographs are inconclusive.

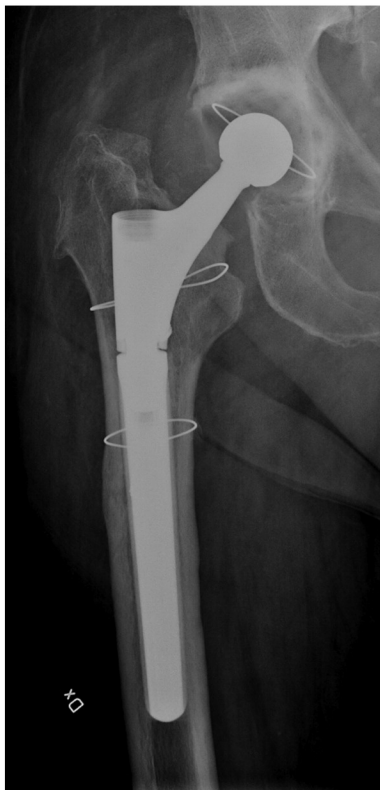
The first patient presented with sudden onset of pain and inability to put weight on his leg. The fracture was obvious on plain radiographs as it was displaced, and this case did not present a diagnostic challenge. The second patient however had an atypical presentation with slowly increasing pain and walking difficulties over a period of a few weeks, until he had to use two crutches. Prosthetic fracture did not seem the most likely cause. Plain radiographs showed no obvious fracture, signs of loosening or other complication (Fig 1). Computed tomography (CT) was performed with 1 mm slices, with and without metal artefact reduction technique.

Fig. 1. Anteroposterior radiograph in case 2, initially described as showing no signs of prosthetic fracture.

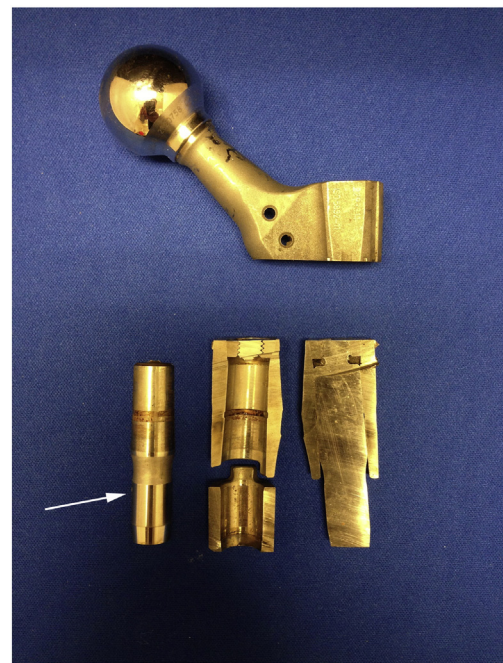
Fig. 2. The mid-stem modular junction of the reference, unfractured Revitan prosthesis after vertical sectioning. On the left is the CoCrMo cylinder connecting the proximal and distal components. In the middle, the surrounding proximal and distal components (with the CoCrMo cylinder removed). The distal component is fixed to the CoCrMo cylinder during the manufacturing, while the proximal component is attached intraoperatively. The arrow shows the level at which the fractures occurred in both cases.
