Component Size Mismatch of Metal on Metal Hip Arthroplasty: An Avoidable Never Event

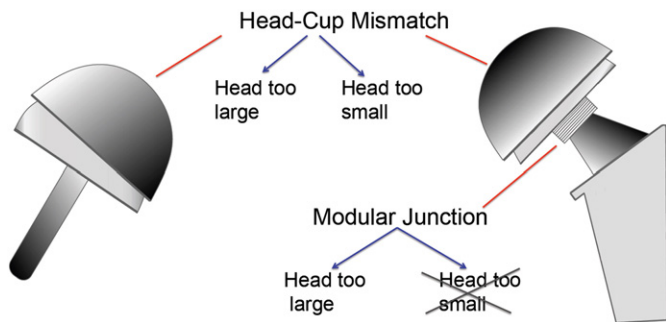
Patient Safety Incidents (PSIs) (32.6%) [4]. Component size mismatch (CSM) is an avoidable complication in hip arthroplasty surgery resulting in both clinical implications for patients and financial ramifications for the healthcare systems [5]. The 2013 National Joint Registry showed that 62 out of 9676 revisions had taken place due to CSM of the head–acetabular socket (0.64%) [6]. Recent advances in hip arthroplasty design, in particular the trend towards greater modularity in hip systems, have increased the risk of CSM. Therefore there is a need for greater vigilance from the orthopaedic community regarding this complication. In addition to mismatch between the femoral head and acetabular cup, CSM can also occur at the taper junction between the femoral head and the trunnion stem (Fig. 1), although the incidence of this is unknown.

Fig. 1. Schematic demonstrating how bearing and taper CSM may occur.

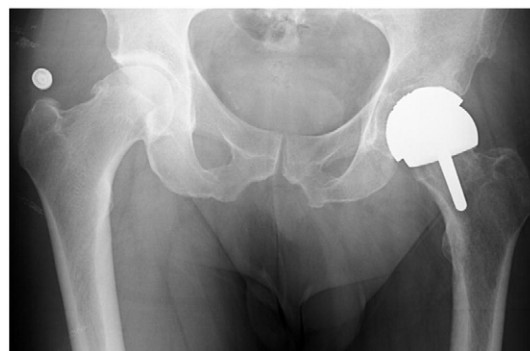
Fig. 2. Plain radiograph of BHR resurfacing with an oversized head.

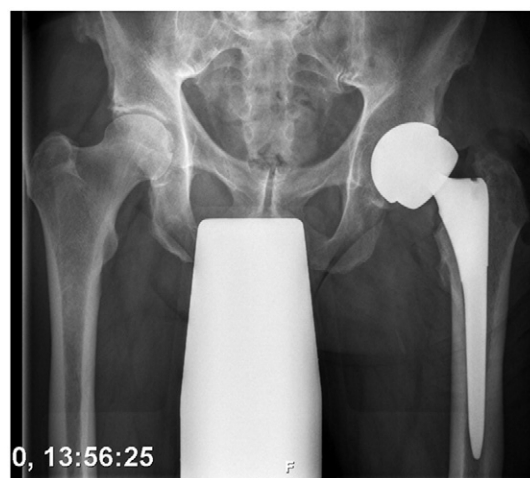
Fig. 3. Plain radiograph of a modular BHR with an oversized head.
