Case Report

Metal Transfer on a Ceramic Head With a Single Rim Contact

Ivan M. Tomek, MD,* John H. Currier, MS,† Michael B. Mayor, MD,†‡
and Douglas W. Van Citters, PhD†

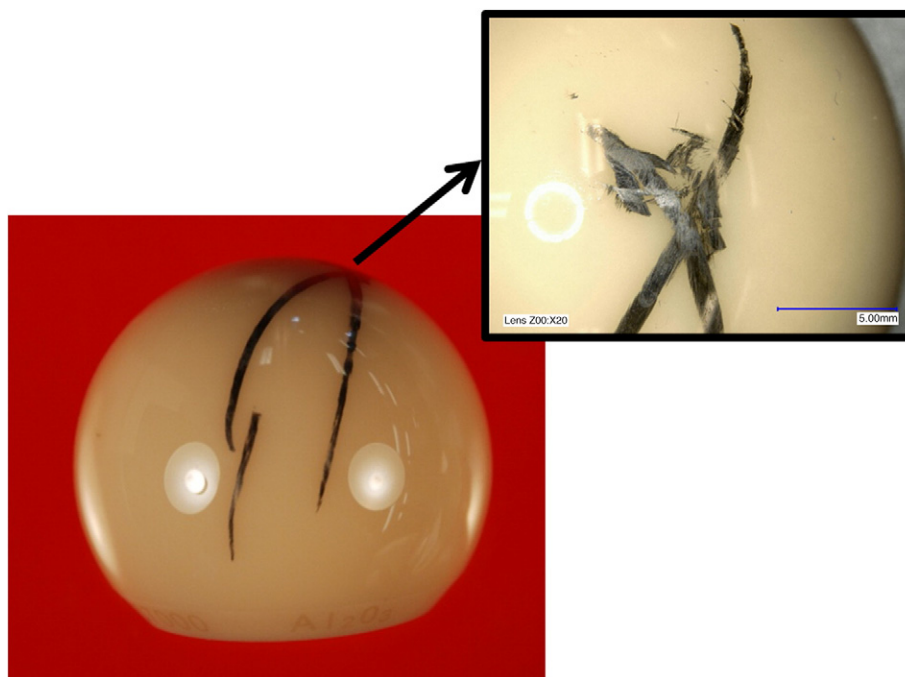
The ceramic head shows 3 distinct lines of metal transfer (Fig. 1). All 3 lines lie along a direction approximately 25° to the right (eg, clockwise) of a line through the polar apex of the head and coincident with the axis of the trunnion. The metal transfer lines vary in width from a tapered point at the end near the equator of the head, growing to approximately 1.1-mm wide at the upper end (nearest the pole). Two of the lines are longer (29 and 34 mm, respectively), and the third is much shorter and situated such that it straddles the equator of the head. The longer 2 lines cross near the pole of the head. There is evidence of the head “dwelling” on the cup rim and shifting in a side-to-side motion, manifest as short smears of metal transfer that emanate out from the linear form of the main line of metal transfer (Fig. 1).

The striated, continuous texture within the metal transfer streaks indicate that, in each instance, the transfer occurred during one excursion of the head across the metal shell rim. The shape of the metal streaks

Fig. 1. Ceramic head at retrieval. Streaks of metal transfer are shown aligned approximately 25° to the right of the line through the trunnion axis. There is evidence of the head dwelling on the cup rim and shifting in a side-to-side motion, manifest as short smears of metal transfer that emanate out from the linear form of the main line of metal transfer (inset of pole region).
