# Fracture of a Cross-Linked Polyethylene Liner Due to Impingement

**Abstract:** We report a case of fracture at 2 years after implantation of a 50-kGy moderately cross-linked ultrahigh molecular weight polyethylene liner with an extended lip (Marathon, DePuy, Warsaw, IN). The extended lip section had fractured. The liner showed no oxidation. The articular surface was grossly deformed, likely due to wear, creep, and/or plastic deformation, and the liner showed no recovery of machining marks upon melting, indicating that some wear had occurred. Electron microscopy revealed fatigue striations on the fracture surface. The likely cause of failure was femoral neck impingement-induced wear and fatigue on the liner. **Key words:** highly cross-linked polyethylene, total hip arthroplasty, impingement, early failure, fatigue failure.

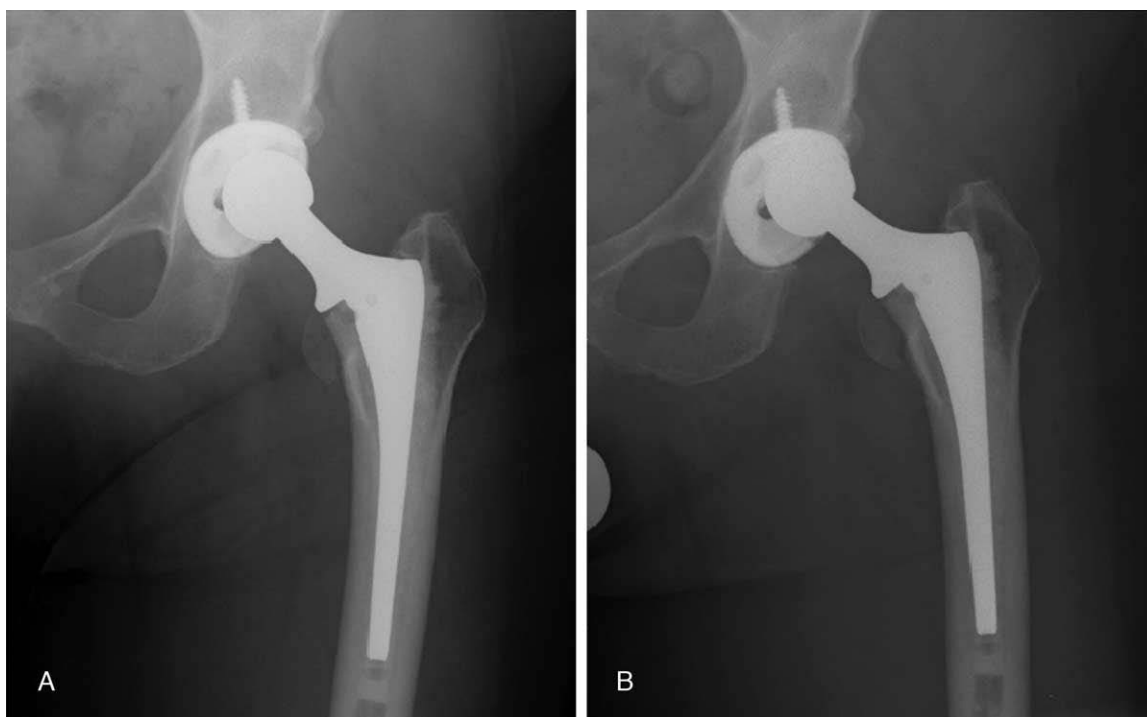
Unfortunately in October 2005, 2 years after her surgery, she heard a loud clunking sound from her hip and presented to the office with pain and crepitation from her hip with ambulation. Radiographs revealed a dramatic superior migration of the femoral head, a significant change from her previous radiographs (Fig. 1).

**Fig. 1.** Radiographs before (A) and after (B) the patient heard the loud “clunking” sound from her hip and began to experience pain and crepitation. The radiographs are approximately 7 months apart.

Revision arthroplasty was performed. During surgery, the polyethylene liner was found to be fractured at the rim near the 10° buildup. Using a similar trial component, the mechanism of impingement was clearly reproduced. In full extension and external rotation, the femoral neck abutted the edge of the polyethylene liner. With a neutral liner, this impingement was avoided; therefore, because the femoral and acetabular components were well fixed, a neutral Marathon liner was placed with a new 28-mm femoral head with 8.5-mm neck length to prevent the impingement.

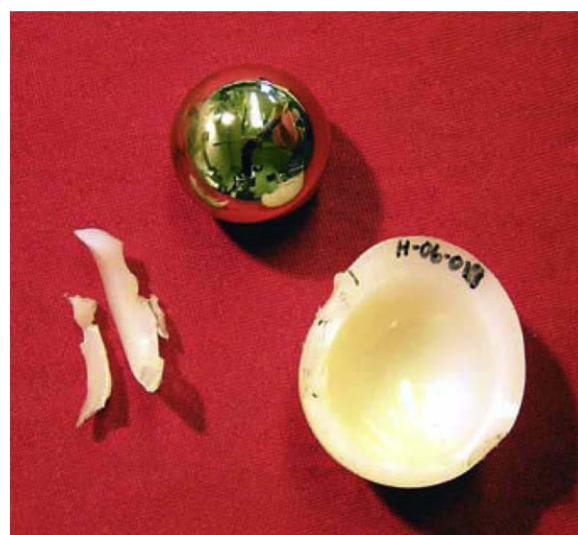
Clinically, the cause of the failure appeared to be impingement of the femoral neck in extension and external rotation leading to wear of the elevated rim causing fracture of the rim and failure of the locking mechanism through fatigue.

**Fig. 2.** The Marathon UHMWPE explanted acetabular liner, along with pieces of its broken rim and its femoral head.
