## Case report

# Adverse tissue reaction to corrosion at the neck-stem junction after modular primary total hip arthroplasty

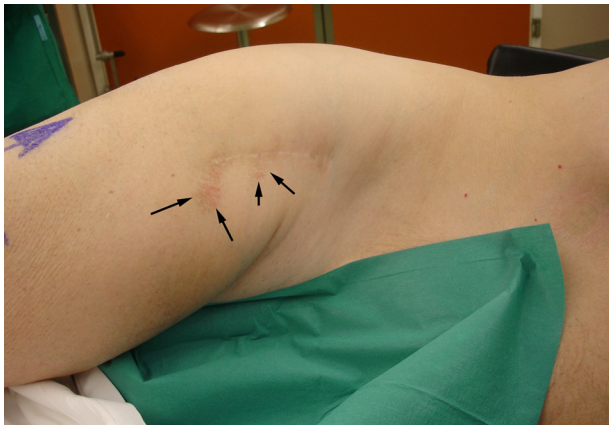
The patient reported gradually worsening hip pain 1 year later. The scar showed no signs of infection but was surrounded by dry eczema lesions typical for hypersensitivity (Fig. 1). Plain radiographs showed osteolysis of the calcar adjacent to the neck-stem junction (Fig. 2). Serum C-reactive protein was 56 mg/L, without leucocytosis. Cobalt and chromium levels were 7.72 µg/L and 1.61 µg/L, respectively. Milky fluid was aspirated from the joint and

**Fig. 1.** Eczema at revision surgery, located around the scar left by the direct anterior approach used for the primary procedure.

The eczema observed before revision surgery was not further evaluated. However, metal-induced cutaneous hypersensitivity reactions have been reported after arthroplasty [15]. The resolution of the skin lesions after implant removal in our patient suggests metal-induced eczema.

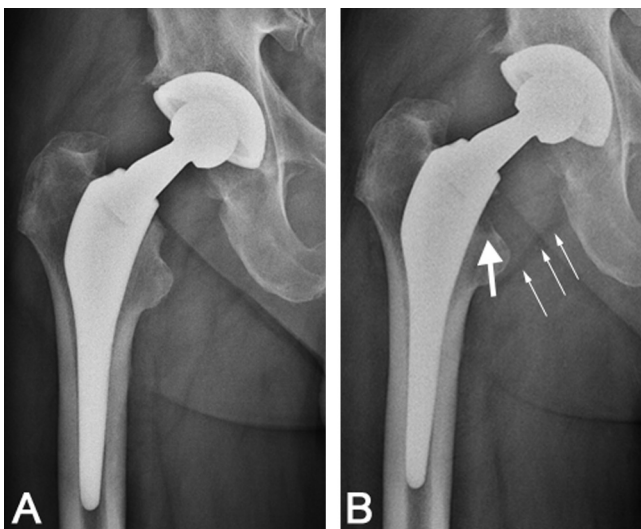
**Fig. 2.** Radiographs obtained immediately after total hip arthroplasty (A) and 1 year later (B): note the osteolysis of the calcar (bold arrow) and the periarticular soft-tissue lesion (small arrows).

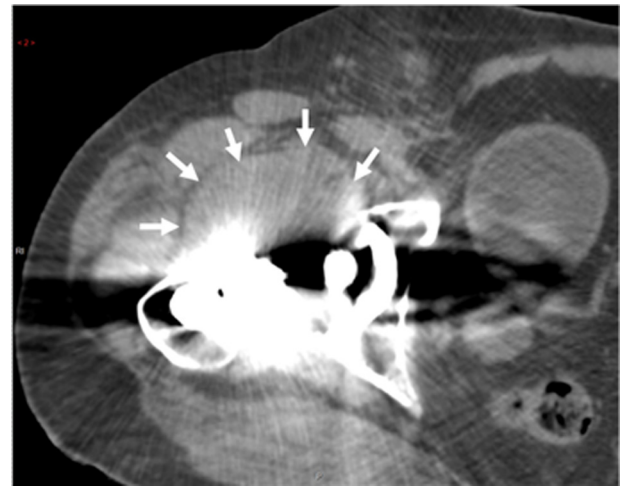
showed no growth upon culturing. A pseudo-tumour was visible around the prosthesis by both CT and magnetic resonance imaging (MRI) (Figs. 3 and 4).

**Fig. 3.** Axial computed tomography image with multiplanar reconstruction along the axis of the prosthesis neck, showing a periarticular lesion of tissue-density (white arrows) in contact with the anterior aspect of the prosthesis neck.

Revision arthroplasty with exchange of the stem, head, and liner was performed. An extensive periprosthetic cystic lesion surrounded by a thick fibrous capsule (Fig. 5) and filled with milky fluid was drained and excised. Reconstruction was with an all-titanium modular revision stem (Lima Corporate, Udine, Italy) and ceramic head. The postoperative course was uneventful. Weight bearing was protected for 6 weeks. Serum cobalt and chromium ion levels were 4.83  $\mu\text{g/L}$  and 1.87  $\mu\text{g/L}$ , respectively, after 6 weeks.
