Case report

Mechanical failure of the Coonrad-Morrey linked total elbow arthroplasty: A case report

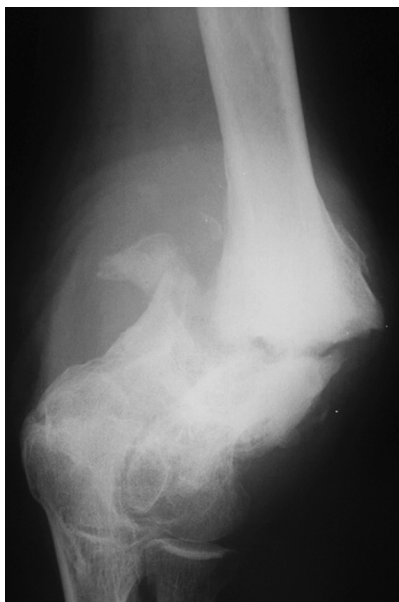
In 2001, a sedentary 61-year-old, right-handed patient presented with nonunion of a supracondylar fracture of the right distal humerus (Fig. 1). CT scan confirmed nonunion and identified joint space disappearance. TEA was therefore indicated. A hinged prosthesis was chosen to obtain stability of the elbow following resection of the epiphysis of the distal humerus. A Coonrad-Morrey® TEA was used (Zimmer, USA).

Fig. 1. Preoperative X-ray showing supracondylar nonunion with destruction of the joint space.

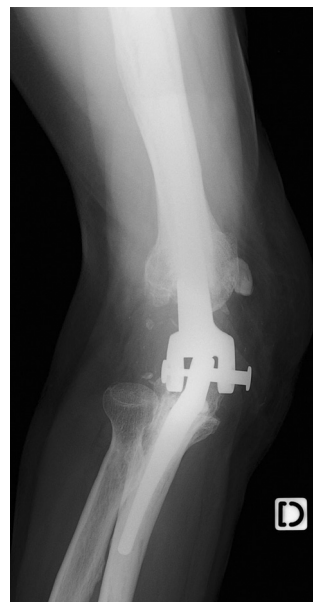
The patient underwent a yearly follow-up consultation. In April 2009, severe wear of the polyethylene bushings of the hinge and axle failure was observed [8]. There was no sign of component loosening (Fig. 3). Surgical revision was performed on May 5, 2009. Metallosis was present due to metal-on-metal contact between the components at the hinge (Fig. 4). The male part of the axle had broken and the 4 flanges had fractured, explaining the separation of the male from the female parts. The polyethylene bushings were worn both in the humeral and ulnar components (Fig. 5). Revision included a synovectomy, changing the different polyethylene bushings and placing a new axle in the hinge mechanism.

Fig. 3. At 8 years of follow-up axle failure is noted; the implants are perfectly cemented.

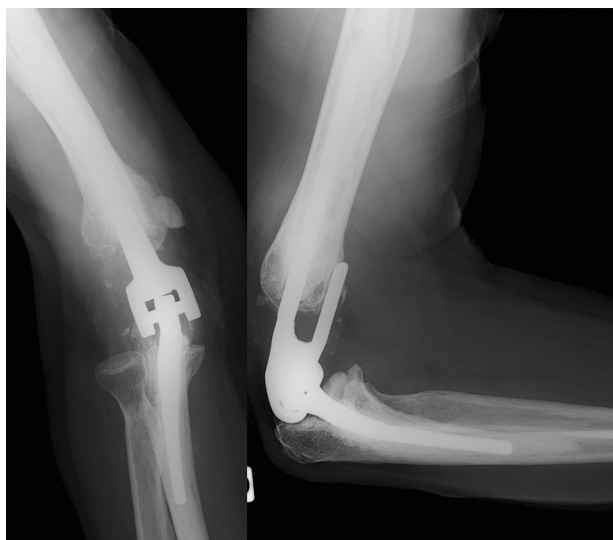
Fig. 2. Postoperative X-ray.

Initial surgery was performed on December 11, 2001. A Bryan-Morrey approach was used and the ulnar nerve was isolated. The distal humerus was resected along with associated ligaments and muscles originating in the epicondyle. A 15 cm humeral component with an elongated anterior flange was cemented to the humeral diaphysis. A standard length ulnar component was also cemented and both components were stabilized by a self-locking axle with male and female parts. The collateral ligaments were not repaired. The intact radial head was preserved (Fig. 2).

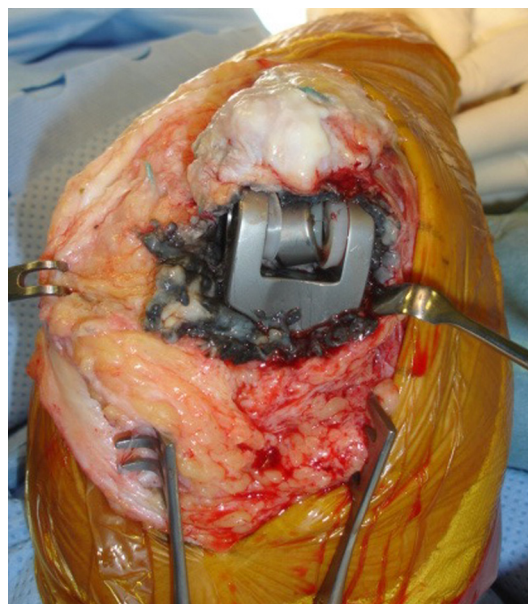
Fig. 4. Perioperative view during revision with metallosis, wear of the polyethylene bushings and metal-on-metal contact between the two implants.
