Tool for inspecting faults from incorrectly cleaved fiber ends and contaminated optical fiber connector end surfaces

Technical Assistance and Support Center, Nippon Telegraph and Telephone East Corporation, 1-2-5 Kamata-honcho, Otaku, Tokyo 144-0053, Japan

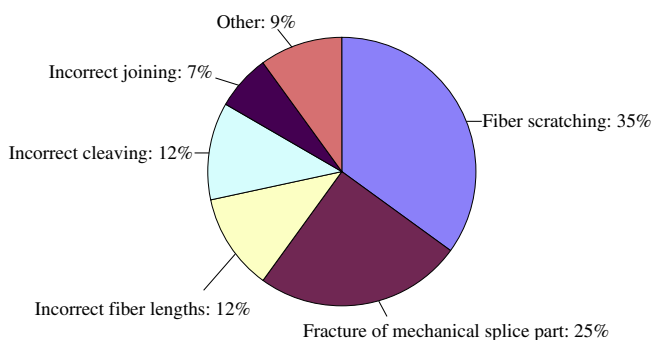
Fig. 2. Summary of direct causes of faults in field installable connectors.

We have investigated faults with field installable connectors. In 2009, we collected defective connectors in a certain region of Japan and investigated these connectors in terms of outward appearance, optical characteristics, and dismantled tests [3]. As a result, we specified the causes of such faults. The direct causes of the faults are summarized in Fig. 2. The causes of connector faults are, in order of occurrence frequency, scratched fibers, fractures of the mechanical splice part, incorrect fiber lengths, incorrect cleaving, and incorrect joining. These faults result from incorrect fiber end preparation and assembly procedures or use of an inappropriate tool. If there are problems with the fiber cleaver in particular, the fiber end would not be cleaved correctly, that is, it would not have an ideal flat and smooth end perpendicular to the fiber axis. An incorrectly cleaved fiber end leads to abnormal joining between fiber ends and may result in an increase in insertion loss [10]. Fig. 3 shows photos of incorrectly cleaved fiber ends. These fiber ends are not flat but uneven. We explain the experimental results from investigating the optical performance of field installable connectors using incorrectly cleaved fiber ends.
