Void fill and support techniques to stabilize drift excavated through a transition zone mined by a TBM at the Stillwater mine

Johnson Josh^{a,*}, Jacobs Curt^a, Ferster Mark^a, Tadolini Stephen^b

^a Stillwater Mining Company, Nye, MT 59061, USA

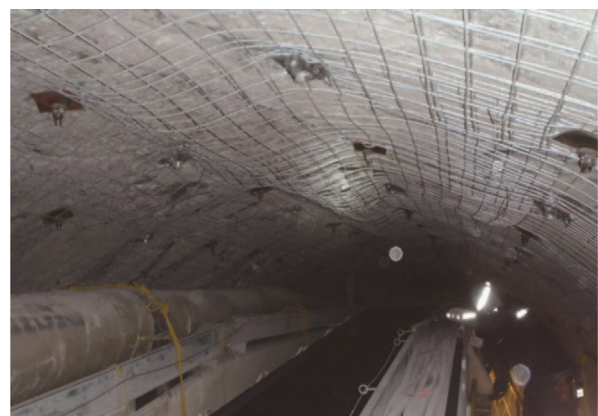
Until August 2014, only one crew operated the TBM four days a week due to the limited availability of experienced manpower. A second crew was added in August. Crews were scheduled Monday through Thursday for day and night shifts, which allowed for maintenance of the TBM over the weekend. By August, ground convergence in the fault zone, shown in Fig. 4, was so great that the steel ventilation ducting on the trailing decks had to be cut off and replaced with smaller oval ductwork to allow the machine to pass.

Fig. 4. Drift convergence August 2014 (mesh was installed tight to rock surface).
