Microelectronics Reliability

Failure analysis methodology on donut pattern failure due to photovoltaic electrochemical effect

Failure Analysis Group, PTF, Globalfoundries Singapore Pte. Ltd, 60 Woodlands, Industrial Park D Street 2, 738406, Singapore

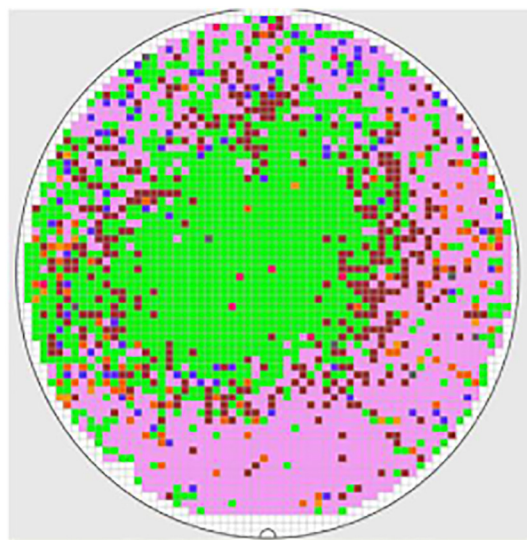
Fig. 1. Typical wafer sort failing map of the affected wafers.

Wafer fabrication encountered a low yield issue with distinct donut pattern analogue failure across several devices. A typical wafer sort failing map was shown in Fig. 1 to illustrate the donut pattern with green colour representing passing dies and pink colour sites representing

dies with analogue failure. As all the affected devices were of the same 65 nm technology node and impacted wafers exhibited similar donut pattern and analogue failing mode, this suggested that there was no device sensitivity and the low yield was related to generic process tool issue.

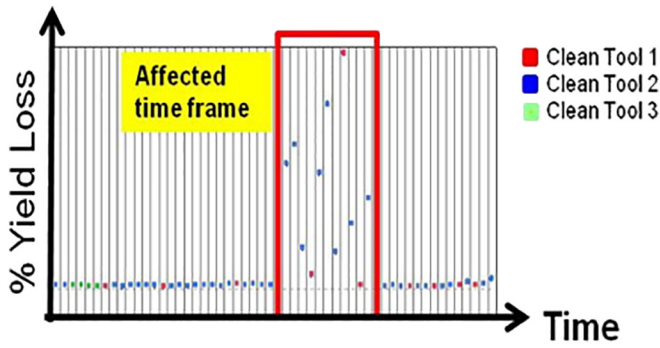
Fig. 2. Correlation of yield loss with clean tool at metal 2 DHF clean step.

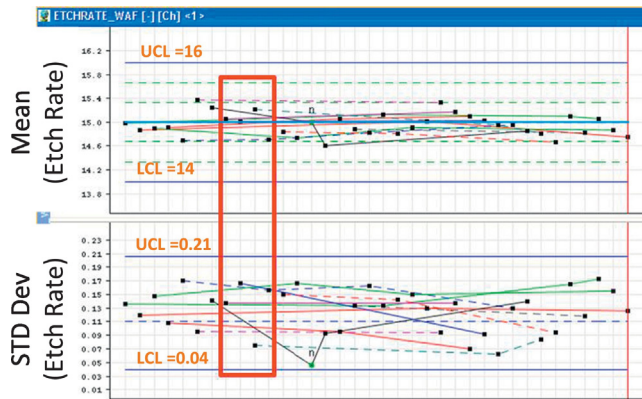
Fig. 4. Control chart of the HF Etch rate in the affected chamber. No abnormal etch rate observed.

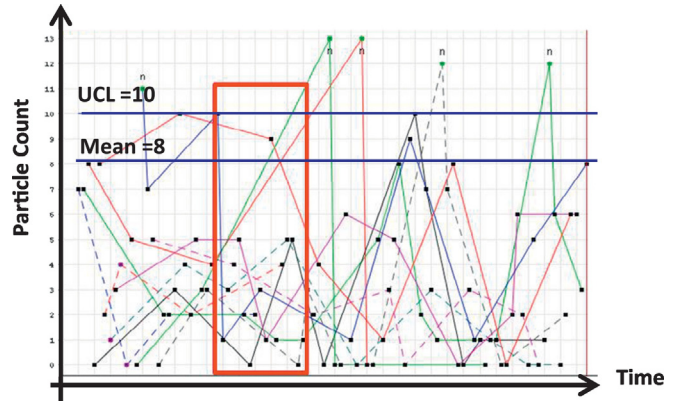
Fig. 5. Control chart showing the particle count. No abnormal particle count of the HF detected in the affected chamber.

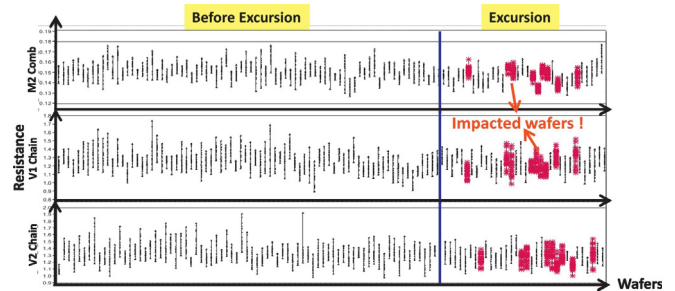
Fig. 6. Via 1 chain/Metal 2 comb/Via 2 chain resistance were comparable between good and bad wafers.
