Microelectronics Reliability

# Novel failure mode of chip corrosion at automotive HALL sensor devices under multiple stress conditions

Semiconductor devices used in automotive applications undergo numerous stress situations depending on their particular application. Corrosion, as one main crucial failure mechanisms, can affect the lifetime of electronic components on system, device or even die level. In this paper, a novel corrosion mechanism on HALL sensor devices is investigated and clarified. This corrosion is only occurring under complex conditions like layout aspects, ionic impurities combined with humidity penetration and thermo-mechanical strain due to packaging and additional mechanical load from further over moulding. It is shown how advanced physical and chemical analysis can be combined with finite element simulation to ascertain a chemical degradation running on silicon, silicon dioxide and metallisation level to derive the complete chemical reaction mechanism for the observed corrosion defects. To verify the new failure mode, experiments to recreate this type of corrosion were carried out. Finally, conclusions are drawn on how failure modes can be prevented and how t

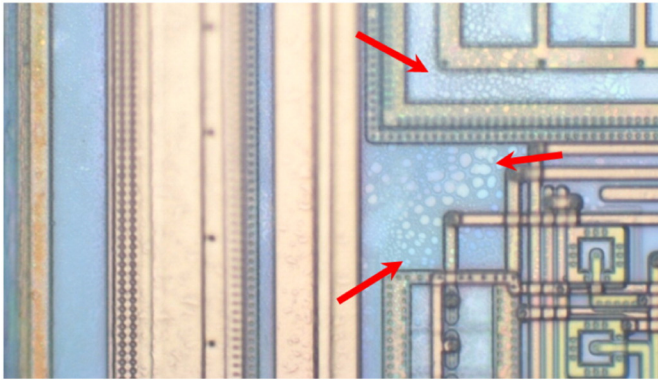
Fig. 1. Light optical image of degraded oxide layers showing voids within insulation in different sizes.

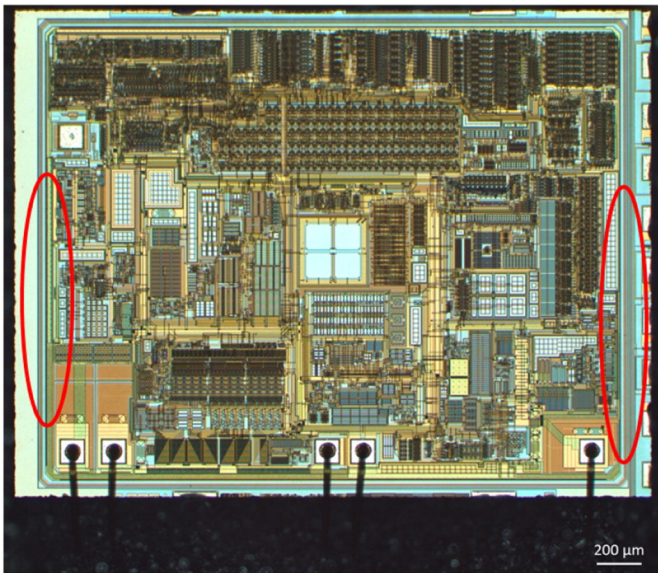
In this paper, a new failure mode related to chip corrosion at linear HALL sensors applied in over-moulded packages for customized car sensing applications was identified. Defective HALL sensor devices showed a failing output signal after 100 km up to 150,000 km lifetime, in different critical applications and at different automotive suppliers. First investigations revealed degradation of the active die structure, see Fig. 1, only at the shorter edges of the HALL sensor die, Fig. 2. Electrical malfunction was caused by locally corroded via structures in this area.

Fig. 2. HALL sensor die with marked main defect areas on the shorter die edges.

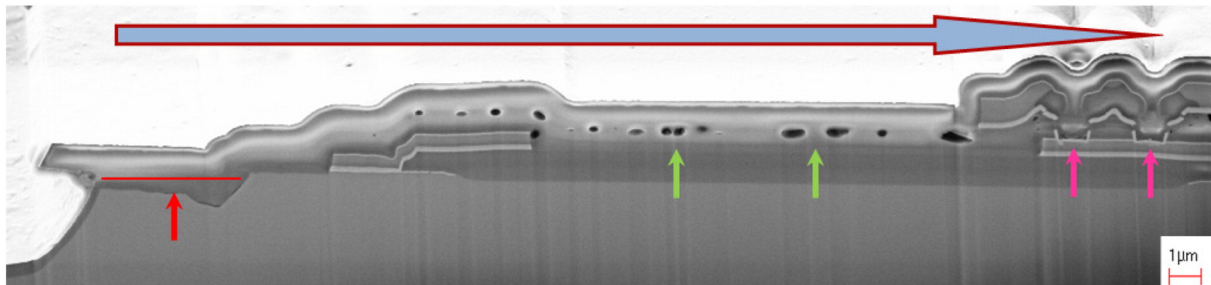
As first step the packages of electrically failed HALL sensor devices were opened using nitric acid (HNO<sub>3</sub>) to get access to the die surface. Then corroded structures at the die edges were identified by optical inspection. The defect area was further investigated by scanning electron microscopy (SEM) at local cross-sections, prepared by focused ion beam (FIB) milling. The complete corrosion path could be seen at this cross-section, starting with degraded silicon substrate, followed by large void formations within the inter-metal dielectric (IMD) layer and finally defective via interconnects, see Fig. 3.

The locally altered silicon substrate was found next to the crack protection trench where the Si<sub>3</sub>N<sub>4</sub> passivation is deposited directly on the silicon. It was found that the silicon was locally attacked in a [1] crystallographic orientation within the affected trench structure, Fig. 4.

The sensor fails if the corrosion reaches via interconnects within the IMD layer close-by the die edge. The interconnect metallisation was degraded and electrically open. It can be seen that the aluminium metallisation within these via interconnects is completely corroded while the TiN barrier is cracked or oxidised.

Fig. 3. FIB cross-section at the defect area near the die edge showing the corrosion of the silicon substrate directly at the trench (left), void formation in IMD layer (middle) and corroded via interconnects (right).
