Microelectronics Reliability

Detection of cracks in multilayer ceramic capacitors by X-ray imaging

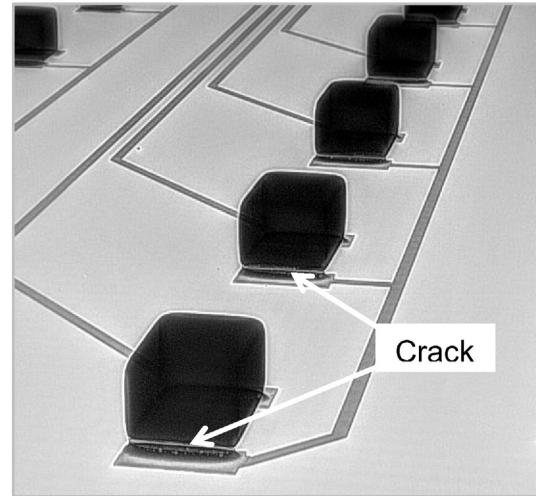
Fig. 3. Overview 2D X-ray image showing several 1812-sized MLCCs placed parallel (0°) to the bending direction, where cracks in all five MLCCs can be seen.

After the bending experiments had been done to various strain levels the test boards were examined with the Nanomex X-ray system. Fig. 3 shows an example of an overview 2D X-ray image take with the detector tilted to 70° , and the cracks in all of the five MLCCs mounted parallel to the bending direction can be seen. This test board was bent to $\delta = 16.5$ mm corresponding to an overall bending strain of 5800 μStr .

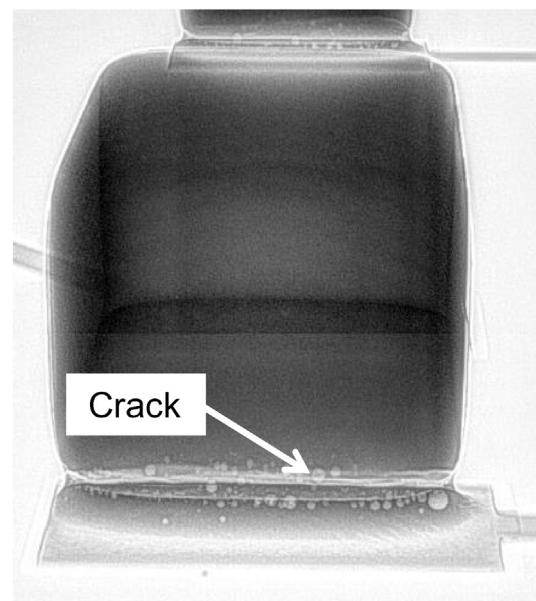
If one MLCC is selected for further magnification, such as for example in the following case the second from below in Fig. 3, the crack is even better visible (see Fig. 4). Still the same detector tilt of 70° is used but a slightly different rotation shows the crack even better. For this image still several smaller cracks are visible as well as voids in the solder are easily detectable, and even the crack in the MLCC behind the centre component is visible at this angle and magnification. The darker area

Fig. 4. Magnified 2D X-ray image of the second from below MLCC in Fig. 3. At the angle of 70° of the detector, the crack in the MLCC is clearly visible.
