Rolling contact fatigue: Spalling versus transverse fracture of rails

Michaël Steenbergen

Delft University of Technology, Faculty of Civil Engineering and Geosciences, Railway Engineering Group, Stevinweg 1, 2628 CN Delft, The Netherlands

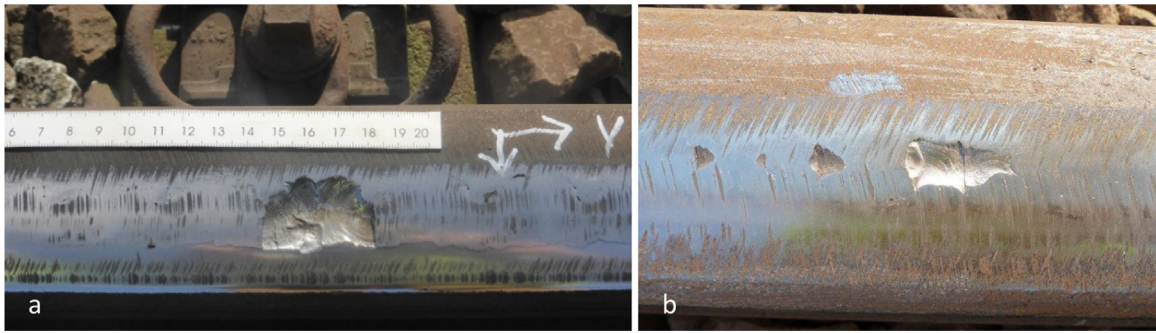
Fig. 1. Spalling defects on grade R370crHT (type MHH) according to classification [3].

Fig. 3 shows an example of a fully developed individual spalling defect, which, like the defect in Fig. 1a, makes part of a longer, repetitive series of identical defects on heat-treated premium rail in the upper leg of a 2240 m radius curve.

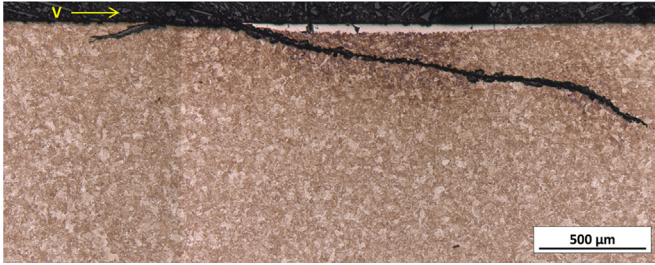
'stud' defect with a thermal origination route in the absence of plasticity is shown in Fig. 2.

Fig. 2. Longitudinal cross-section over a 'stud' defect on grade R350HT according to classification [3].
