# Wear of hardfaced valve spindles in highly loaded stationary lean-burn large bore gas engines

In this work, Stellite<sup>®</sup> and Tribaloy<sup>®</sup>-hardfaced valve spindles with different operating hours and from the same gas engine were analyzed in terms of quantitative wear, oxidation and microstructural alterations in the wear scar. The observed wear mechanisms are based on microstructure fatigue and delamination, depending on the microstructure of the hardfacing. The severely worn sealing interfaces show no tribofilm at all, whereas a protective oxide layer is observed on the surface of the Tribaloy<sup>®</sup> hardfacing that features low wear.

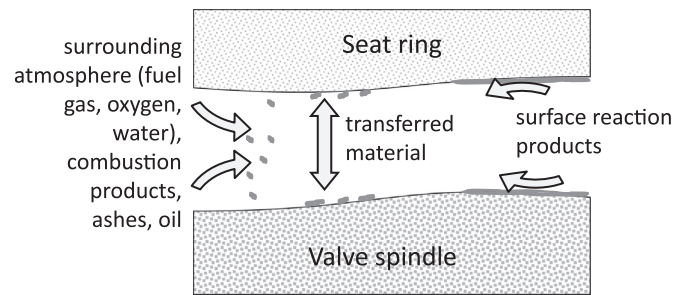
Most studies on valve wear point out the presence of a protective tribofilm on the seating faces. Three sources of educts for the formation of a protective tribofilm are known from literature and can be confirmed by the authors for lean-burn large bore gas engines, as depicted in Fig. 1:

- Partially burned and combustion products of fuel and oil form deposits on all accessible surfaces inside the combustion chamber, especially on the seating faces of valve and seat ring [5];

Fig. 1. Possible sources of educts for tribofilm formation in the contact of seat ring and valve.

- Transferred material from seating faces of the seat ring to the valve and vice versa, which undergoes grain refinement and can form a built-up layer based on adhesion [10,12];
- Chemical reaction products of the surfaces with the surrounding atmosphere, enhanced by the high operating temperatures, preferably forming oxide layers [4,14].
