# Case Studies in Engineering Failure Analysis

## Failure of 321 stainless steel heater tube in heavy crude oil

H.M. Shalaby\*, K. Ravindranath, N. Tanoli, B. Al-Wakaa

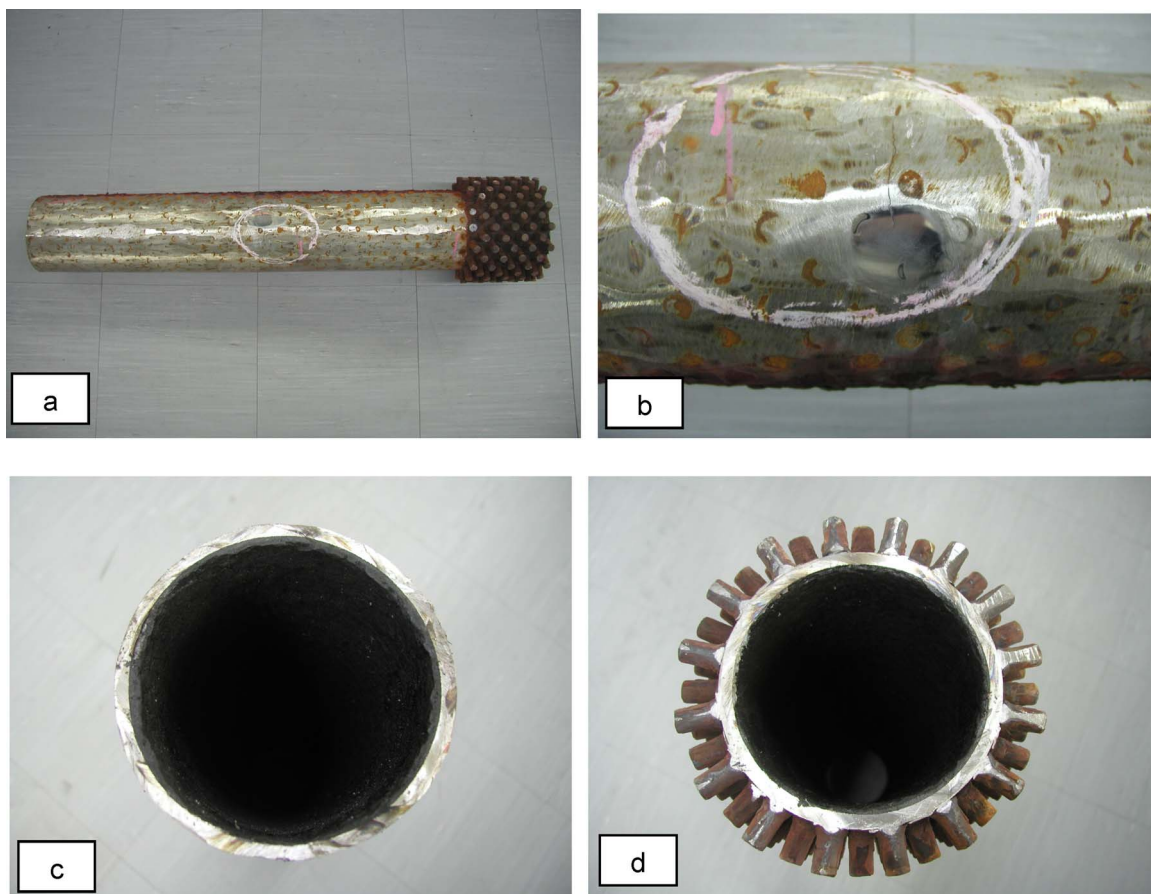
Fig. 1. Camera photographs showing (a) as-received tube section; (b) circumferential crack seen after removal of studs; (c) deposited black layer on internal surface; and (d) stud portion of tube.

made of 321 SS had black oil/coke deposits on their external surfaces. The deposits were seen on the first two rows of plain tubes. The observations were made through available gaps between tubes, as access to the convection tubes was severely limited. In order to identify the leaky tubes, the refinery engineers pressurized the heater. However, no leak was detected as seen from the radiant zone. The eight plain tubes having black deposits were removed from the heater, which facilitated inspection of stud tubes. One stud tube in the third row was found to have black deposits. This tube was also removed, and the removed nine tubes were replaced with new ones. The removed 321 SS tubes were examined using dye penetrant test. No indication was found on all tubes. However, when the stud tube was lightly grounded externally at the black colored area, a circumferential crack was visually observed (Fig. 1a and b). The presence of this crack raised the possibility that the remaining heater tubes in operation may also have cracks.
