Metallurgical analysis of a failed maraging steel shear screw used in the band separation system of a satellite launch vehicle

S.V.S. Narayana MURTY *, Sushant K. MANWATKAR, P. Ramesh NARAYANAN

Material Characterization Division, Materials and Metallurgy Group, Vikram Sarabhai Space Centre, Trivandrum 695 022, India

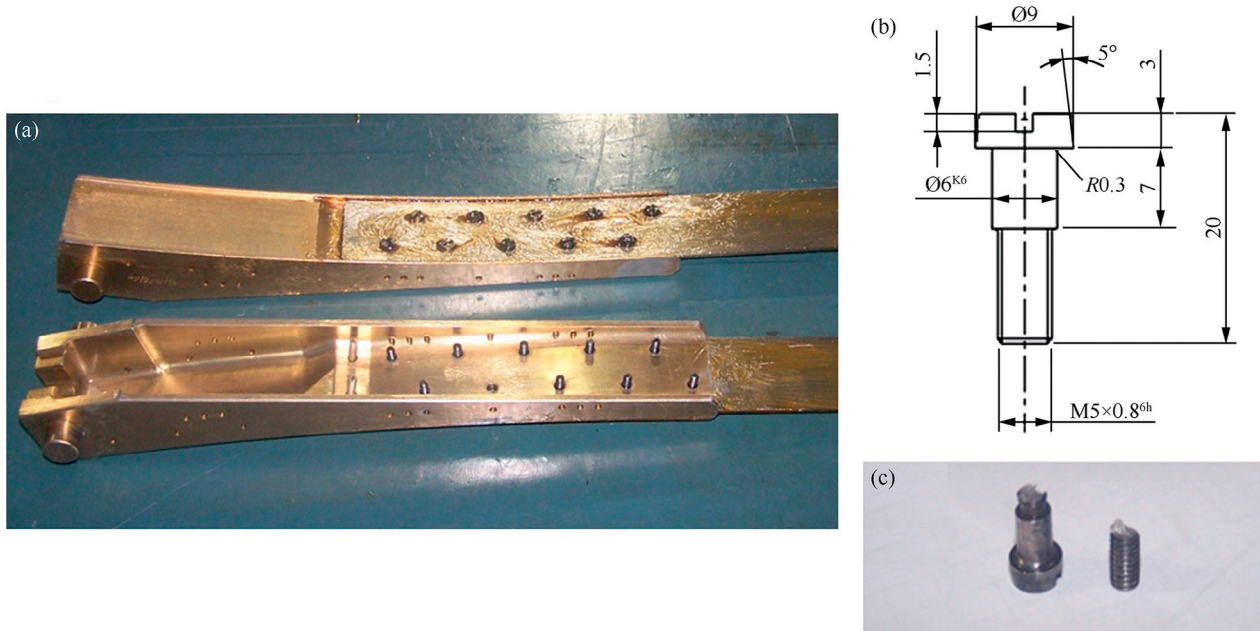
Fig. 1. (a) Photograph of the band with shear screws in place (except the failed one left with an empty slot) along with (b) drawing of the fastener and (c) photograph of the failed shear screw head (left) and shank (right).

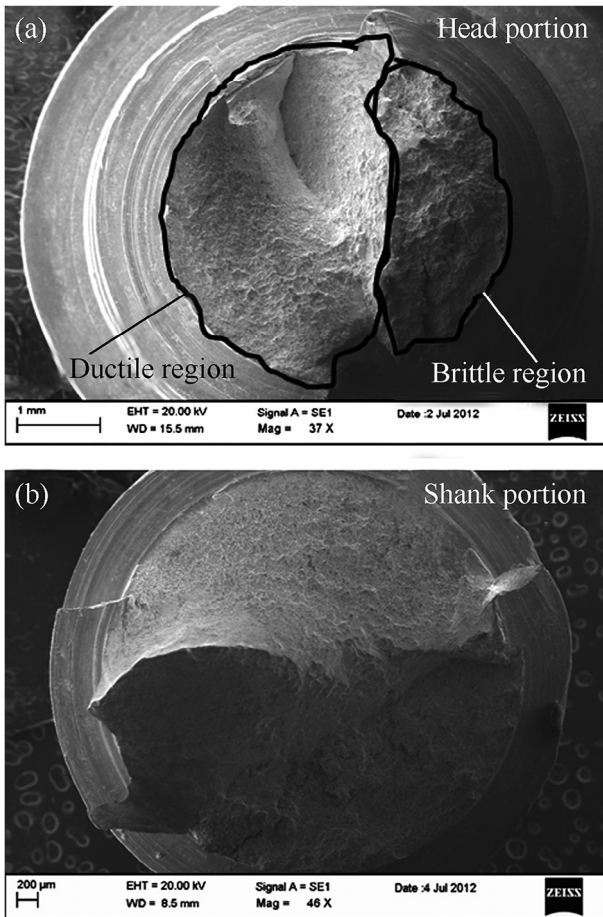
Fig. 2. Scanning electron micrograph (a) showing the fracture surface (head portion) of the shear screw having two distinctly separate regions (marked ductile region and brittle region) and (b) showing the fracture surface of the failed counterpart shank portion. Note the minor difference in the magnification of two photographs.

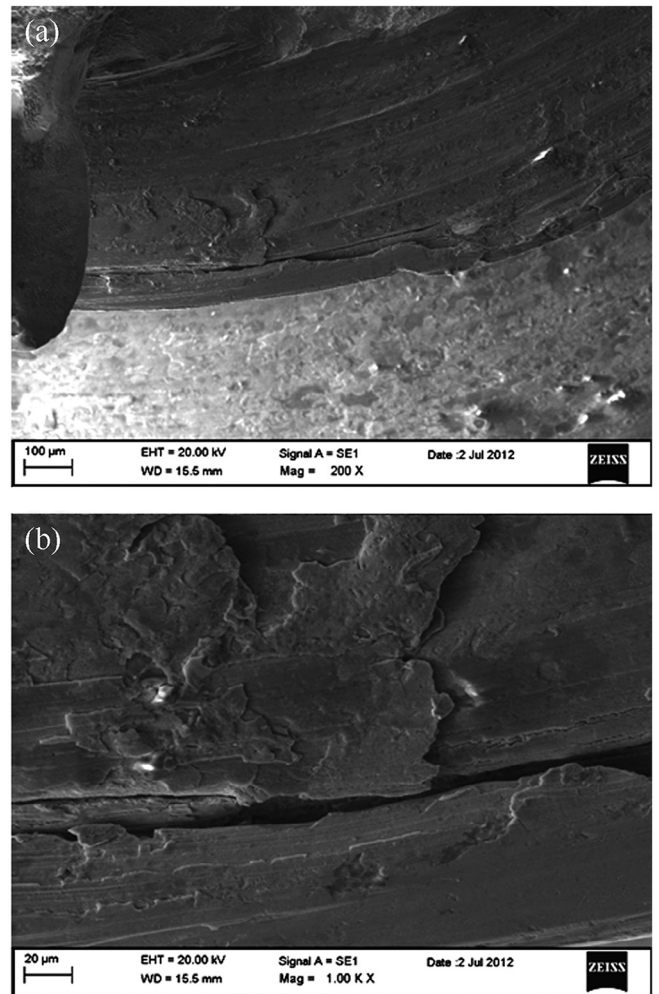
Fig. 3. Scanning electron micrographs showing defects in thread regions of the shear screw showing local attack and cracks.
