# Engineering Failure Analysis

## Interactive effect of ant nest corrosion and stress corrosion on the failure of copper tubes

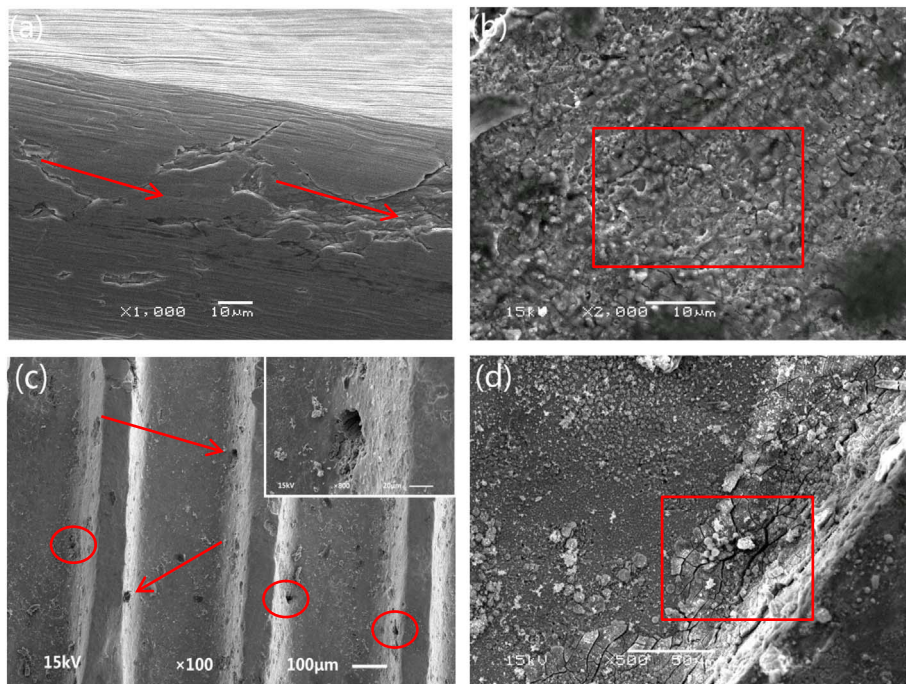
Fig. 1 shows the surface morphology of leakage copper tubes which serviced in air-conditioning units. Fig. 1(a) & (b) are the morphology of outer surface and Fig. 1(c) & (d) are the morphology of inner surface. In Fig. 1(a) & (b), several micro-cracks can be seen obviously. Actually, these micro-cracks are the laminations/folds which could have been produced during tube manufacturing. Besides, several pitting corrosion can be observed obviously on the inner surfaces at the areas with red marks and the partial magnify image of pitting hole is also shown in the inset in Fig. 1(c). In addition, the pitting holes are distributed regularly, almost all pitting distribute on the bottom of internal groove. In other word, the bottom of internal groove can be identified as the starting points of corrosion. As the Fig. 1(d) show, many micro-cracks are concentrated at the bottom of internal groove on the inner surface. These micro-cracks formed possibly at the initial preparation or using process of the copper tube due to the stress concentration [12] and

Fig. 1. The surface morphology of leakage copper tubes observed by SEM (a, b are the micro morphology of outer surface, c, d are the micro morphology of inner surface observed by SEM).
