Engineering Failure Analysis

Failure analysis of high nickel alloy steel seal ring used in turbomachinery

The purpose of this study is to identify the failure cause of the steel seal ring used in nuclear steam turbines. New high nickel steel alloy seal ring was compared with the failed seal ring. Metallographic analysis, scanning electron microscopy, nanoindentation and in-situ tensile testing were used to analyze the reasons of the seal ring failure at both macroscopic and microscopic scales. The main reason of the seal ring failure is a combination of stress and elevated temperature during turbine operation. Complex work environment caused recrystallization and recovery, resulting in grain refinement and secondary phases precipitation. Many secondary phase precipitates appeared at grain boundaries during use, causing formation of microvoids and cracks, ultimately leading to ring failure.

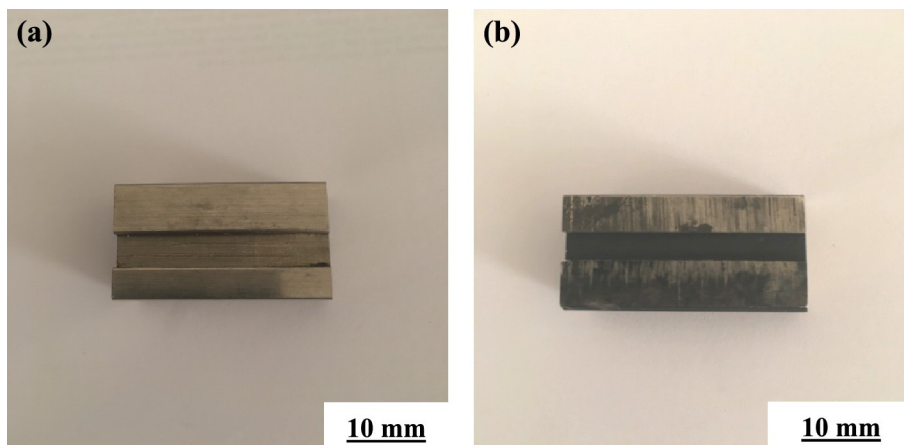
Macroscopic and microscopic analyses were used to identify material failure. Table 1 lists measured diameter, width, opening gap length and gap lateral displacement of the failed and the new seal rings, shown in Fig. 3. While there are no obvious differences in the rings diameter, the opening gap length of the failed ring is larger, along with the gap lateral displacement. Thus, it is apparent that the used rings have undergone macroscopic plastic deformation, contributing to seal ring failure.

Fig. 2. Specimens cut from: (a) New seal ring; (b) Used seal ring.
