## Engineering Failure Analysis

# Analysis of Boeing 737 aircraft towing accidents

Shu-wen Chen\*, Hui Liu, Fu-hai Li

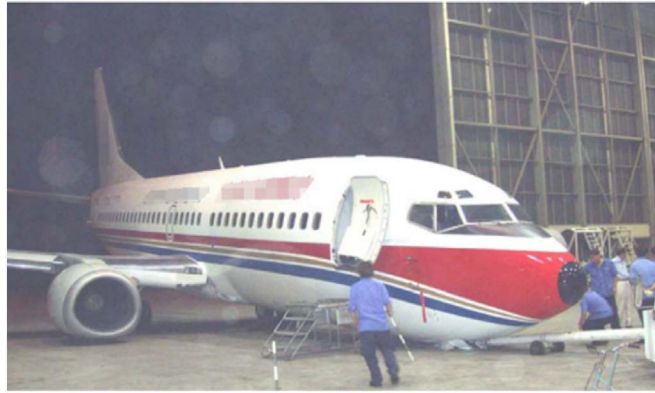
The nose of aircraft pressed down on towbar in both failure cases, as shown in Fig. 1. Several structures of nose landing gear were damaged that the down drag and the lock link of nose landing gear were ruptured. A large area of depression and a crack were found on the nose gear well aft bulkhead, as shown in Fig. 2. The other areas of nose landing gear were found some mechanical scratches.

Fig. 1. The failure state of aircraft.

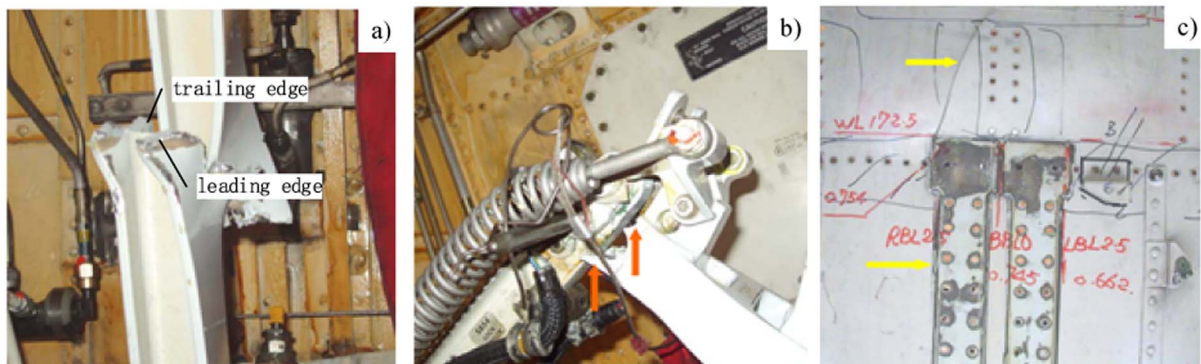
The rupture of down drag was happened in the middle position, and the trailing edge of sectional I-beam was obviously shrinkage deformation near the fracture of down drag. Experimental examinations were performed to fractured structures (taken the observer face to the aircraft as the reference orientation), and the fracture morphology of down drag and shear pins of towbar were shown in Figs. 5 and 6, respectively. The chemical composition of down drag is similar to 4340 steel: Si 0.34, Cr 0.88, Mn 1.28, Ni 1.66 and Fe Alloy Structural Steel. Rockwell hardness of the cross section of down drag was HRC46.0 which equaled to 220 psi of the tensile strength.

The upper description and analysis was about the accident in 2004. The fracture characters in the failure case of 2005 were similar. The failure analysis showed that the failure mode of down drag, shear pins and other structures was overload fracture caused by excessive traction load. In addition, we found obvious joint gaps between aircraft, towbar, and tractor through field investigation, as shown in Fig. 7, which might have been the cause of the impulse load under conditions of tractor breaking or passing the trench of oil filler pipes.

Fig. 2. Details of the fractured structures of nose landing gear: (a) down drag; (b) lock link; (c) aft bulkhead.
