Engineering Failure Analysis

Failure investigation of 321 stainless steel pipe to flange weld joint

Failure investigation was conducted on a refinery pipe-to-flange weld joint that suffered cracking. Both the pipe and flange are made of AISI 321 stainless steel. The flange was circumferentially welded to the pipe which is seam welded. The investigation revealed that both the circumferential and seam welds were in sound conditions, namely no evidences of sensitization, lack of weld penetration, and voids or porosities. Thus, welding practices were not suspected to be the cause of failure. The failure of the weld joint was found to have started at the δ -ferrite phase in the flange material and propagated through the circumferential and seam welds. The failure mode was concluded to be chloride stress corrosion cracking synergized by the presence of H_2S . The presence of corrosive compounds in the refinery stream and the residual stresses at the weld joint triggered active anodic dissolution of the δ -ferrite precipitates, resulting in cracking of the material.

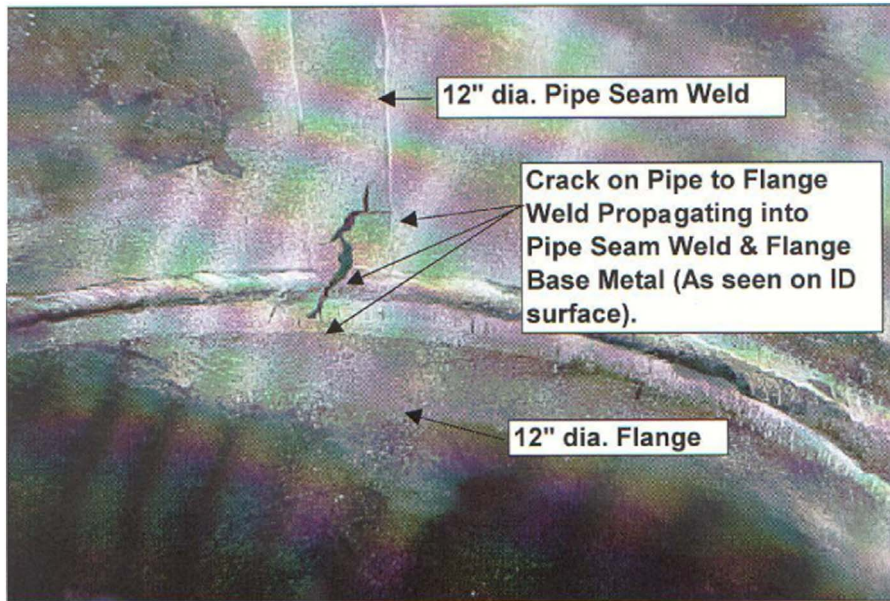
Fig. 1. Photograph showing location and appearance of the crack found in the weld joint at the internal surface.

A leak was observed at the external surface of a pipe to flange weld joint located in the downstream of a refinery heat exchanger tube side outlet. The pipe is 12" in diameter and is seam welded. It is circumferentially welded to the flange. Both the pipe and flange are made of 321 SS. The leak was in the form of a pinhole at the heat affected zone (HAZ) of the circumferential weld. When dye penetrant test was applied, a crack was found in the internal surface at the weld joint (Fig. 1). The internal surface was covered with an adherent black scale. The crack propagated across the circumferential weld and extended towards the pipe seam weld. Table 1 shows the composition of the fluid stream going through the pipe. The operating temperature and pressure through the pipe are 192 °C (377 °F) and 1780 psig, respectively. The hydrogen pressure is 2850 psig.
