Engineering Failure Analysis

Understanding the effect of soil particle size on corrosion behavior of natural gas pipeline via modelling and corrosion micromorphology

Bin He^{a,c}, Pengju Han^{a,b}, Lifeng Hou^b, Decheng Zhang^c, Xiaohong Bai^{a,*}^a College of Architecture and Civil Engineering, Taiyuan University of Technology, Taiyuan 030024, PR China^b College of Materials Science and Engineering, Taiyuan University of Technology, Taiyuan 030024, PR China^c Department of Civil Engineering, Monash University, Clayton, Victoria 3800, Australia

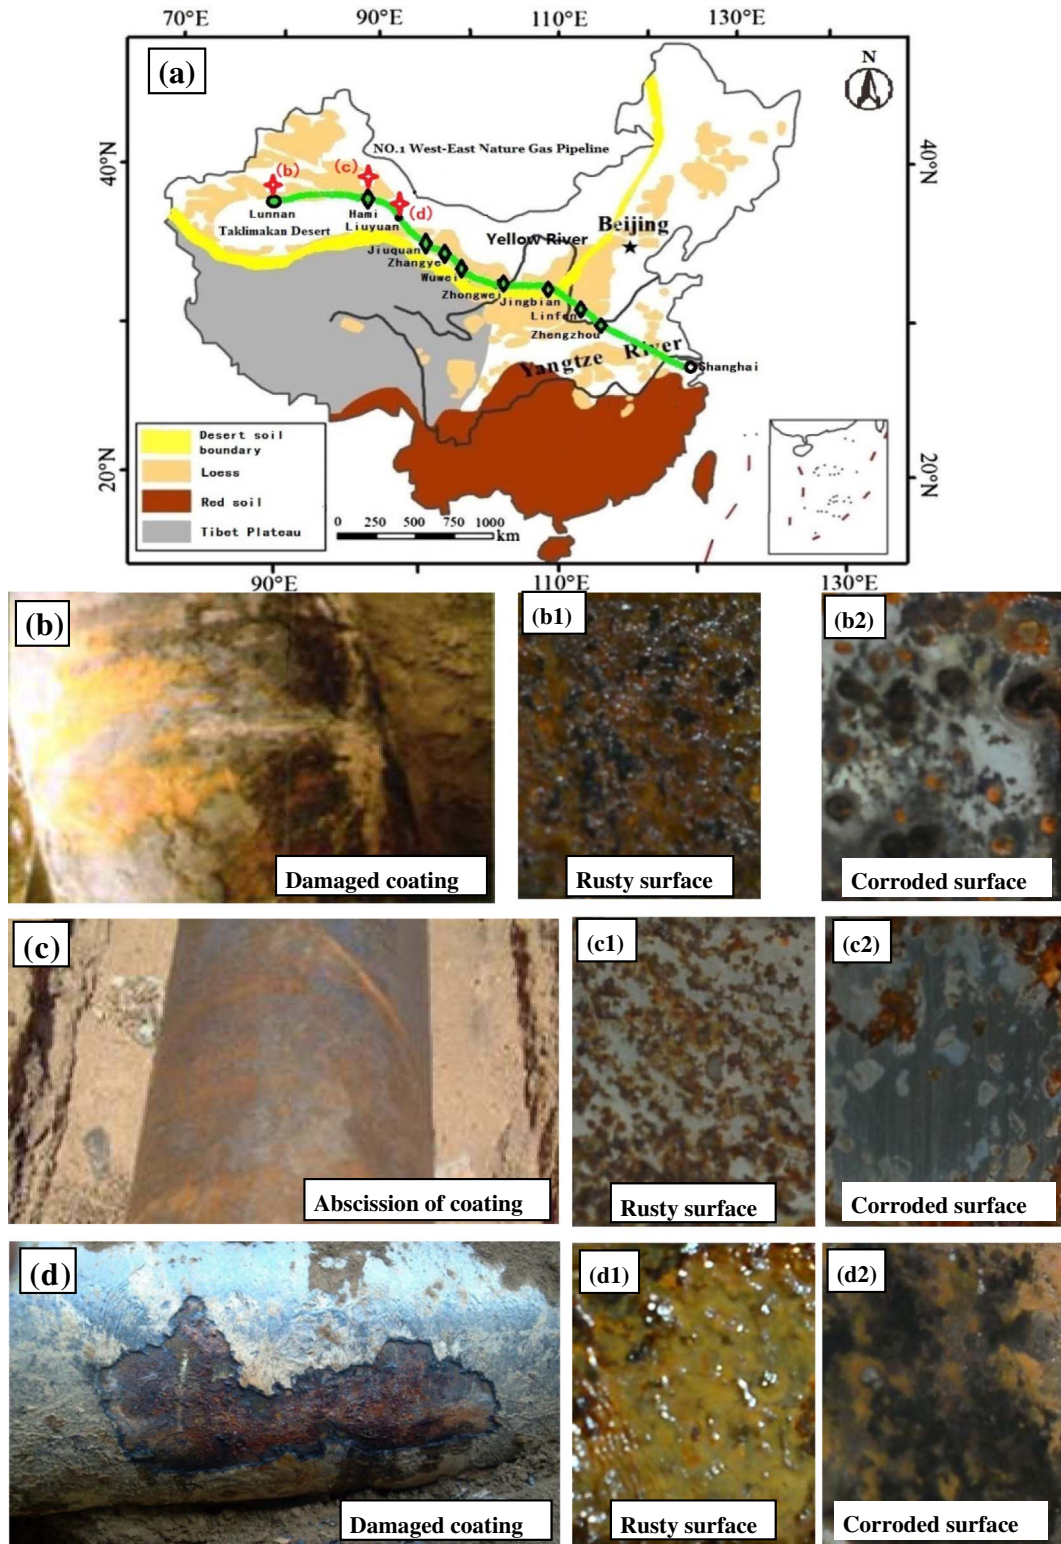
The No.1 West-East Gas Pipeline (1-WEGPL) Project was developed to transmit natural gas from the western part of China to the east, travelling about 4000 km. Furthermore, two thirds of the pipeline is buried in the desert of saline soil in Northwest China [1], as shown in Fig. 1(a). The integrity of gas pipeline is maintained by a three-layer PE coating and cathodic protection (CP). The 1-WEGPL serviced well during the early period, however, soil corrosion problem became increasingly serious with the service time increased [2]. Fig. 1(b), (c) and (d) shows the severity of in-situ pipeline corrosion from the Lunnan, Hami and Liuyuan stations, respectively. Fig. 1(b1), (c1) and (d1) are close snapshots of the corrosion products. Fig. 1(b2), (c2) and (d2) are the close-ups of corroded surface. Obviously, the pipe steel suffered more serious corrosion in Liuyuan and Lunnan stations than that in Hami station, evidencing by the corrosion morphologies of pipe steel and the large number and depth of corrosion pits on the metal surface. According to the analysis of the physical and chemical properties of soil around these stations, the water content, salinity and chemical composition of soil samples in Liuyuan, Lunnan and Hami stations are different. The details are includes in appendix. Moreover, it is worth noting that the particle sizes of the soil in Lunnan station is the smallest, and in Liuyuan station is the biggest, while in Hami station is the medium size. This is resulted from the more serious wind erosion in Lunnan which is in the vicinity of the Taklimakan Desert.

Fig. 1. The 1-WEGPL of China (green line): (a) the desert regions of China (north of the yellow line); (b) A view of coating failure and the corroded pipeline in Lunnan station; (b1) and (b2) is the close-up of the corroded gas pipeline of rusty and corroded surface in Lunnan station, respectively; (c) A view of coating failure and the corroded pipeline in Hami station; (c1) and (c2) is the close-up of the corroded gas pipeline rusty and corroded surface in Hami station; (d) A view of coating failure and the corroded pipeline in Liuyuan station; (d1) and (d2) is the close-up of the corroded gas pipeline rusty and corroded surface in Liuyuan station, respectively. (For interpretation of the references to color in this figure legend, the reader is referred to the web version of this article.)
