# Failure analysis of the wall tubes of a water-tube boiler

Camilo A. Duarte\*, Edgar Espejo, Juan Carlos Martinez

Department of Mechanical & Mechatronics Engineering, Universidad Nacional de Colombia, Bogota, Colombia

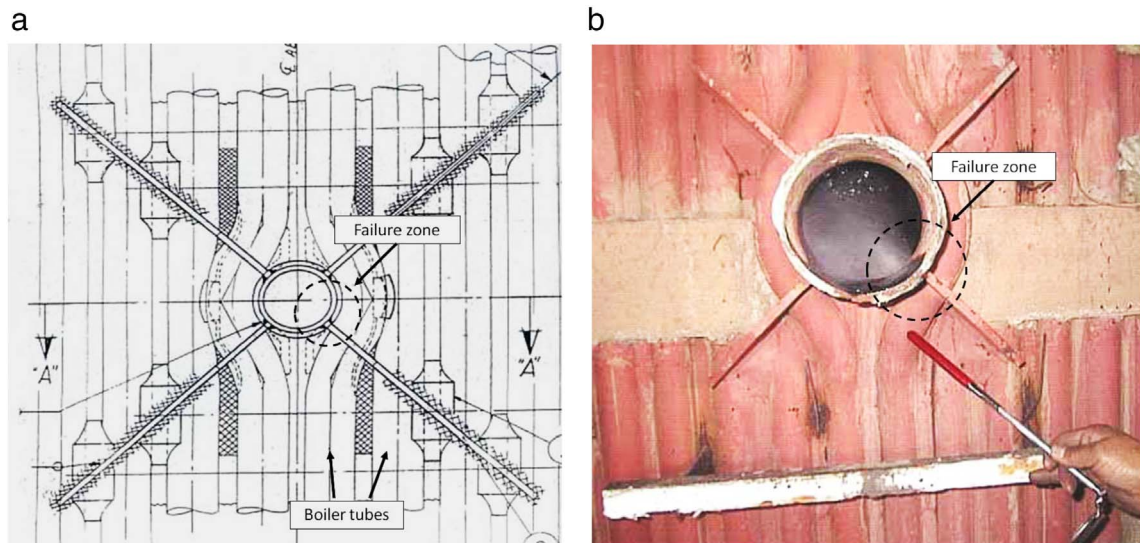
Fig. 1. (a) Schematic drawing of the water-tube boiler showing failure zone and (b) macrograph of the water-tube boiler showing crack zone in the wall tube.

The boiler started to operate in 1999. In 2001, one of the boiler tubes presented a leak in its bent section. Over this area, a crack at an approximate angle of 45° to the tube axis was identified, as well as pitting corrosion on the inner surface of the tube; the corrosion pits were concentrated in the bent section of the tubes (see Fig. 2b and c). Six months later, the same symptoms were exhibited by another tube. At the failure site, the operating parameters were a pressure of 150 bars and a temperature of 350 °C, and the operating medium was saturated steam (see Table 1). In 2006 all remaining bent tubes were removed (eight), showing corrosion pitting on their inner surface.
