Engineering Failure Analysis

Experimental analysis of contact fatigue damage in case hardened gears for off-highway axles

A. Terrin ^{a,b}, C. Dengo ^b, G. Meneghetti ^{a,*}

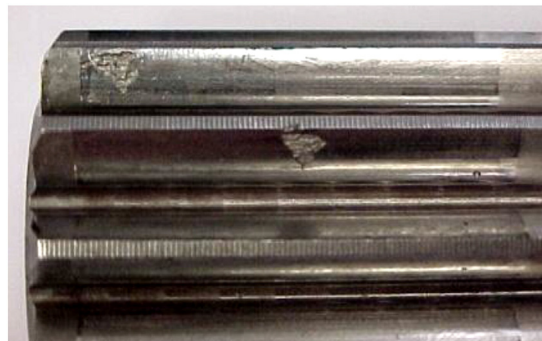
Fig. 2. PSO macropitting.
