Fatigue failure analysis of high speed train gearbox housings

Weigang Hu*, Zhiming Liu, Dekun Liu, Xue Hai

School of Mechanical, Electronic and Control Engineering, Beijing Jiaotong University, China

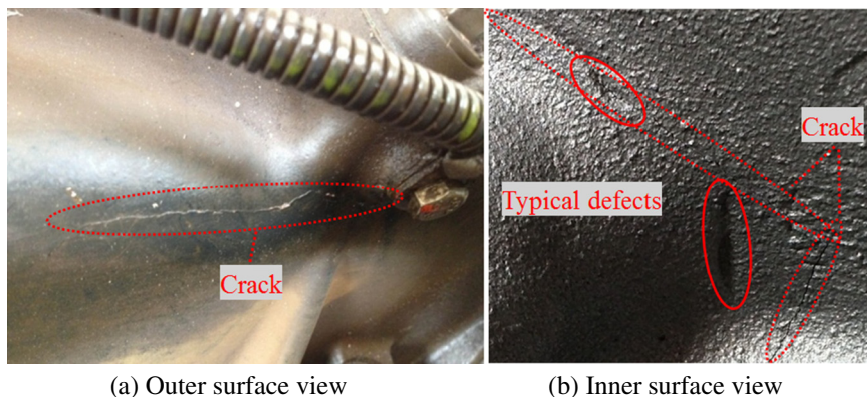
Fig. 2. Crack position of the gearbox upper housing.

The gearbox housing is fabricated by the sand casting of an aluminum alloy. Its chemical composition and hardness meet the requirements of related standards and technology agreements. Gearbox housing fractures are mainly located in proximity to the inspection window of the upper box near the thread hole on the wheel-axle side, as shown in Fig. 2(a). It is obvious that a typical casting process produces defects on the inner surface of the viewport, and the inner surface is rough, as shown in Fig. 2(b).

The macroscopic fracture morphology on the rough inner surface of the gearbox housing, as shown in Fig. 3, indicates that crack initiation begins at the inner surface of the upper box, with radial fatigue lines clearly expanding toward the external surface, which is the most conspicuous feature of fatigue failure [11]. The fracture region can be divided into a smooth area and a rough area. The smooth area represents the region of crack initiation and propagation. The rough area represents the terminal region where the propagated crack has attained a critical width.
