Failure investigation of a cooling coil tube in zinc roaster furnace

M. Ananda Rao ^{a,*}, R. Sekhar Babu ^b, M.V. Pavan Kumar ^c^a CSIR-National Metallurgical Laboratory Madras Centre, Chennai, India^b Paradeep Phosphates Limited, Paradeep, India^c Department of Chemical Engineering, National Institute of Technology Calicut, Kerala, India

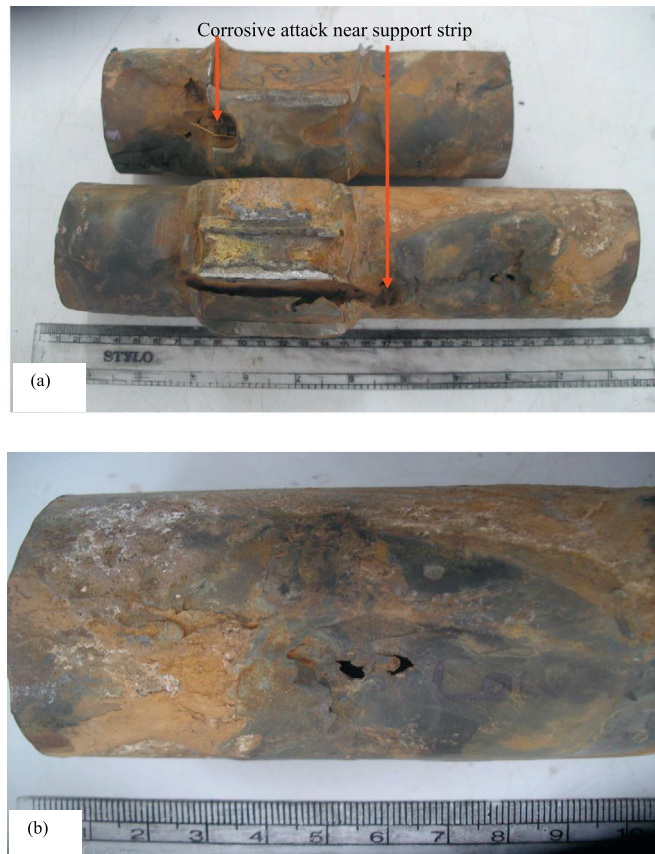
Fig. 1. (a) Failed cooling coil tubes in as received condition. (b) Close visual observation near the failure.
