Investigating and interpreting failure analysis of high strength nuts made from nickel-base superalloy

Dallen L. Andrew^{a,*}, Scott S. Carlson^b, John H. Macha^a, Robert T. Pilarczyk^{c,1}

^a Southwest Research Institute, San Antonio, TX 78238, United States

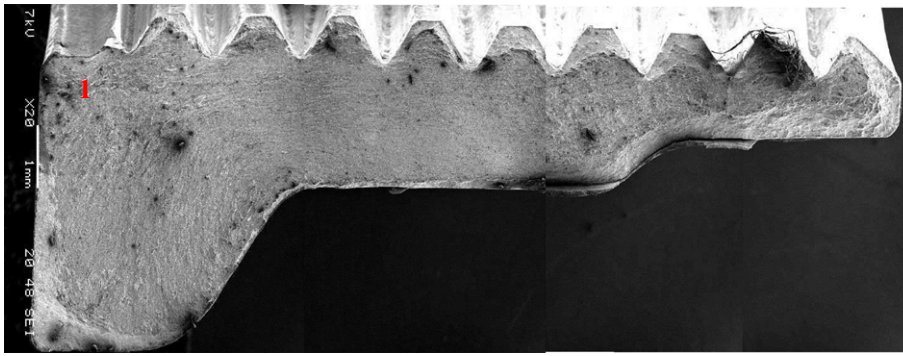
Fig. 1. Composite of SEM micrographs showing fracture surface topography for the failed EWA nut from [3].

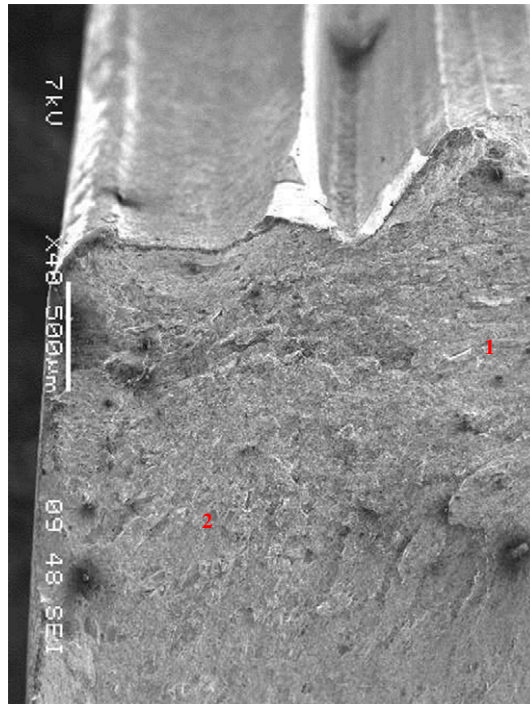
Fig. 2. SEM micrographs showing fracture surface topography in corner region Location 1 in Fig. 1 for the failed EWA nut from [3].
