Failure analysis of a carbon steel pipeline exposed to wet hydrogen sulfide environment

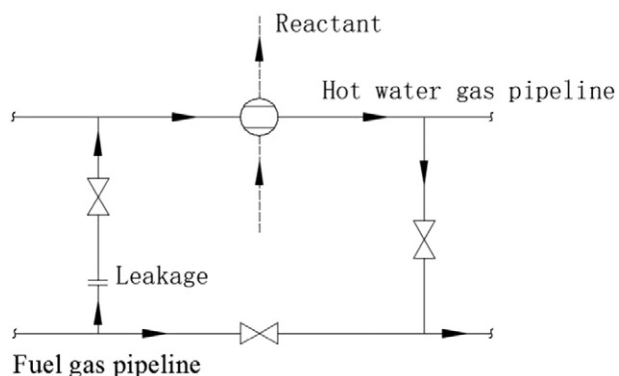
Fig. 1. Diagram of fuel gas pipeline.

The leakage location of fuel gas pipeline in reforming unit is shown in Fig. 1. The leakage was caused by the cracking of the pipe at the cross line between the fuel gas pipeline and the hot water gas pipeline.

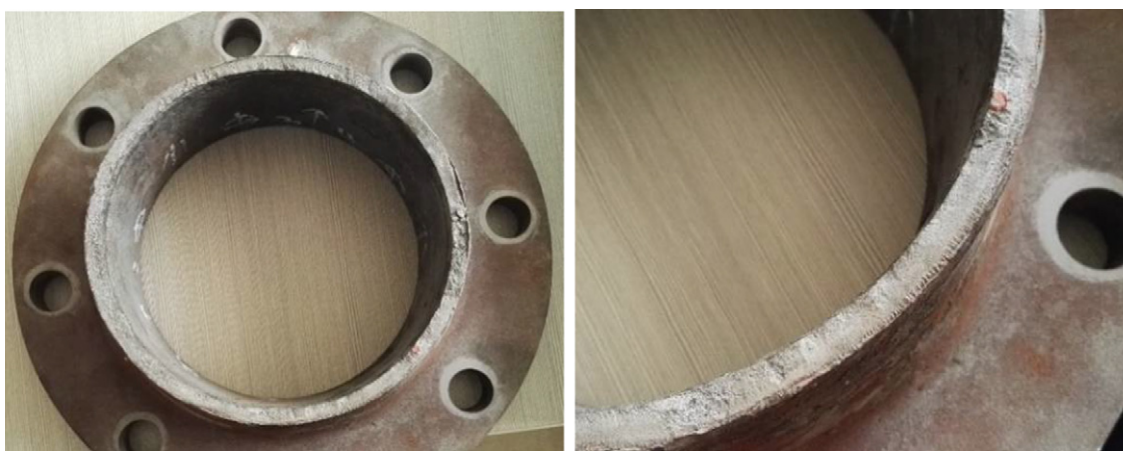
Fig. 2. Macro appearance of fracture surface.

The shear-lip is very narrow as shown in Fig. 2. When the crack is extended to the near surface, the shear stress is the leading factor and causes shear tearing. The outer surface of the fracture has obvious shear-lip, and the shear-lip is very thin. Shear-lip width reflects the material toughness, tear rate as well as the thickness of the component. Therefore, it can preliminary viewed that toughness of the weld joint is poor, which may be caused by missing or improper stress relief annealing.
