# Local rolling contact fatigue and indentations on high-speed railway wheels: Observations and numerical simulations

Xin Zhao <sup>a,\*</sup>, Boyang An <sup>b</sup>, Xiaogang Zhao <sup>a</sup>, Zefeng Wen <sup>a</sup>, Xuesong Jin <sup>a</sup>

<sup>a</sup> State Key Laboratory of Traction Power, Southwest Jiaotong University, Chengdu 610031, China

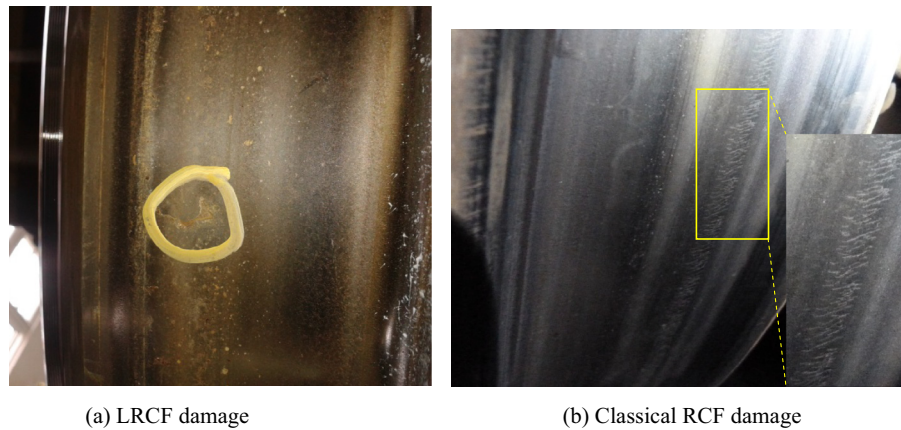
A rolling contact fatigue (RCF) problem on high-speed wheels (one-piece forged wheels), as shown in Fig. 1(a), has drawn great attention in China since 2012 owing to its potential threat to running safety. Because of its isolated occurrence on the tread, the problem is referred to as local rolling contact fatigue (LRCF) hereinafter to distinguish it from the classical RCF occurring continuously along the circumference of wheels (see Fig. 1(b)). Cracks of LRCF are observed during wheel reprofiling to be typically 2.5–8.5 mm deep, and their extent on the tread enlarges with the cutting depth owing to their shallow angles to the surface, as indicated in Fig. 2. Furthermore, many LRCF defects are not instantly recognizable from the tread surface (see Fig. 1(a)). To better understand its initiation, propagation, and consequences, intensive studies have been conducted in the past years. This paper presents some field observations and statistical results on LRCF, followed by numerical studies to reveal its initiation mechanism. A study on the classical RCF of high-speed wheels in China was recently published in [1]. Before showing the results, the research background is further elaborated in the following subsections.

Fig. 1. RCF of high-speed wheels in China.

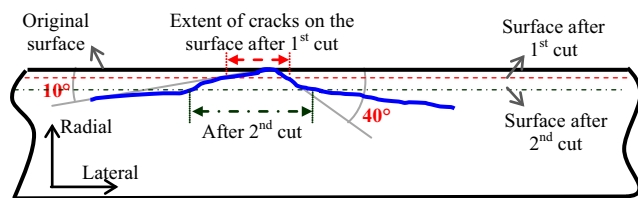
Fig. 2. Cracks (in blue) traced from a lateral-radial section of an LRCF sample. (For interpretation of the references to colour in this figure legend, the reader is referred to the web version of this article.)
