Symposium of the International Society for Rock Mechanics

Managing Risks on an Active Haul Road Adjacent to a Propagating Subsidence Zone at Telfer Gold Mine

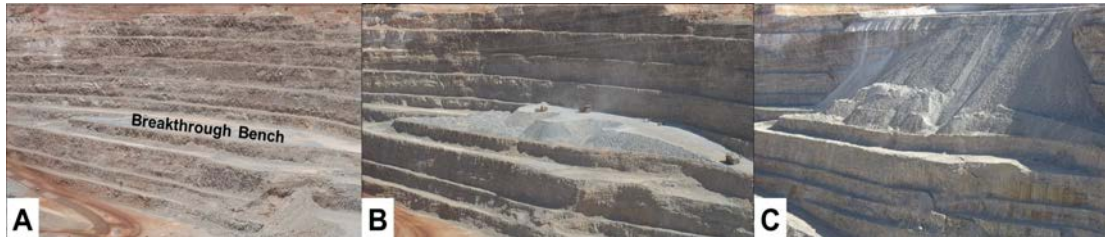
Fig. 1. Preparations for Cave Breakthrough Bench (a) Breakthrough bench & high wall in 2008; (b) Commencement of backfilling to buttress high wall in February 2009; (c) Completion of backfill buttress in October 2009 and initial cave breakthrough (cracking) observed on slope below breakthrough bench.

At the completion of backfilling in October 2009, pit wall movement and major cracking was occurring on the slope below the Breakthrough Bench (Figure 1c) in response to continued SLC mining underground. The Upper West Ramp was located directly below this area and is illustrated in Figure 2d. A comprehensive deformation monitoring programme and trigger-action-response-plan (TARP) were utilized for the early detection of potential hazards or instabilities. With continuing SLC operations and the progressive growth of the subsidence crater, the Upper West Ramp became unserviceable in 2011 following a nearby slope collapse and extensive cracking on the ramp. As illustrated by Figures 2d and 2e, the subsidence zone continued to expand over the next five years. Significant cracking was identified on and adjacent to the Lower West Ramp in 2014 which resulted in it being designated as a restricted access area for dewatering activities only.

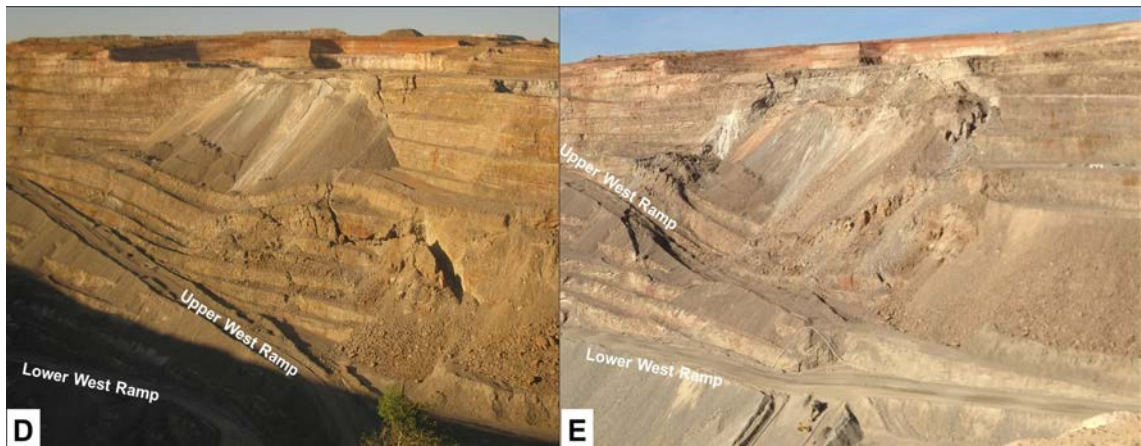
Fig. 2. Cave Subsidence Zone (d) 2011 (2 years after breakthrough) Cracking and deterioration of Upper West Ramp commenced; (e) 2016 (7 years after breakthrough) Cracking becoming visible adjacent to Lower West Ramp; Upper West Ramp not-serviceable but did not catastrophically collapse.
