9th International Conference „Bridges in Danube Basin 2016“, BDB 2016

Degradation of steel footbridges with neglected inspection and maintenance

Jaroslav Odrobiňák ^{a,*}, Richard Hlinka ^a

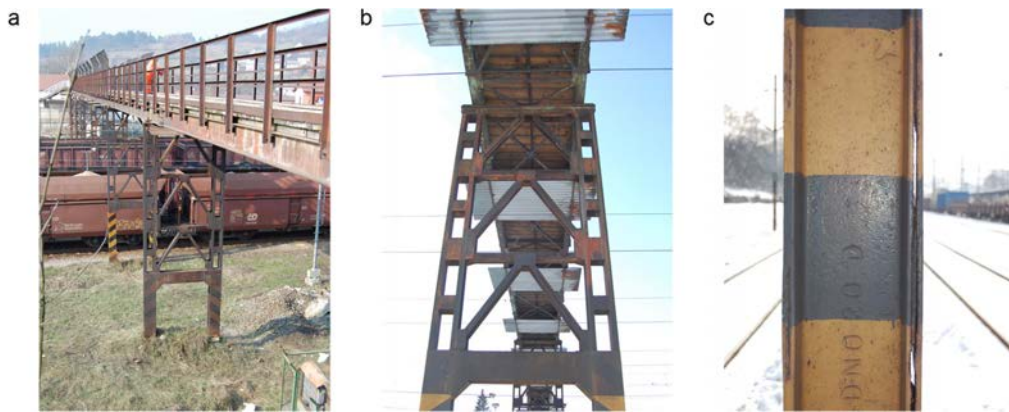
Some of piers are affected by uniform corrosion, but without significant losses, Fig 1b. However, in the case of two piers large-scale crevice corrosion formatted due to water penetration into the gap between the plate and rolled sections where improper plug welds was used to create closed cross-section of the pier columns, Fig. 1c. Crevice corrosion is also evident between plates of bearings on the top of nearly all piers.

Fig. 1. (a) overall view of the footbridge #1; (b) bottom view; (c) crevice corrosion of the pier columns.

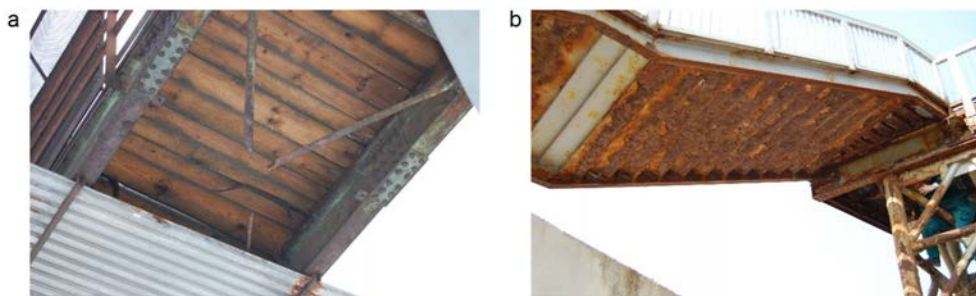
Definitely, the most affected by corrosion are the bridge deck elements, especially in older part of the footbridge. Corrosive losses on the crossbeams are significant and it is only a matter of time when their condition become emergency. Completely degraded by the corrosion are many members of horizontal bracings. Actually, some members are totally destroyed and the rest of them cannot satisfy expected static function, Fig. 2a. Application of road-spreading salt in winter leads to degradation of the individual parts of the side stairway. From the bottom view is evident degradation of steel plates creating stair steps, especially, Fig. 2b.

Fig. 2. (a) corrosion of deck members; (b) corroded steps of the staircase.
