9th International Conference „Bridges in Danube Basin 2016“, BDB 2016

The road steel bridge over Bosut river in Serbia Part 2 – Repair and Reconstruction

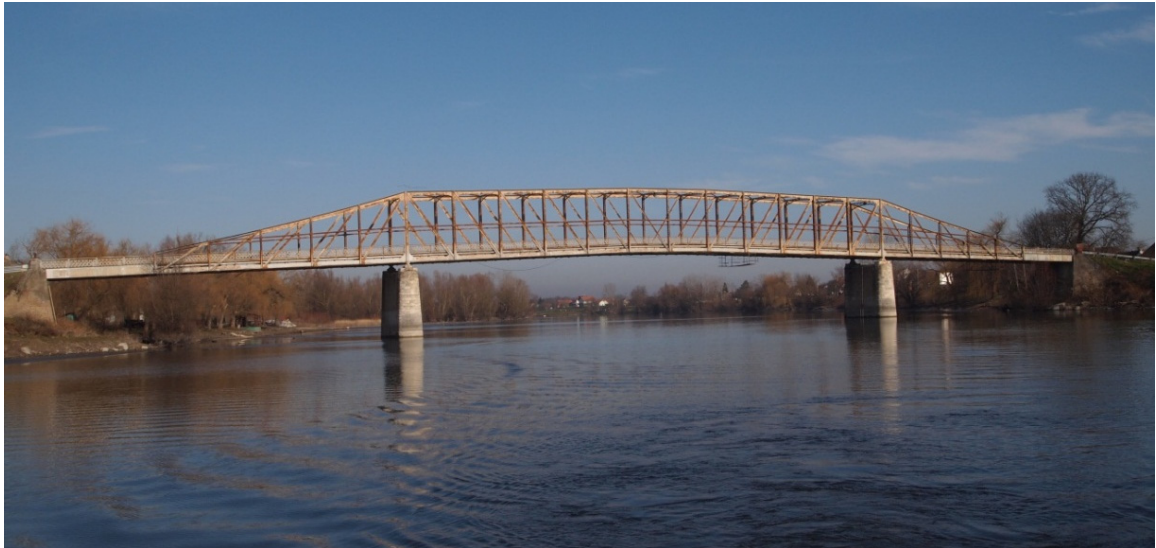
Fig. 1. Appearance of road steel bridge in Morovic
