Microbiologically influenced corrosion (MIC) in stainless steel heat exchanger

E. Huttunen-Saarivirta^{a,*}, M. Honkanen^a, T. Lepistö^a, V.-T. Kuokkala^a, L. Koivisto^b, C.-G. Berg^c

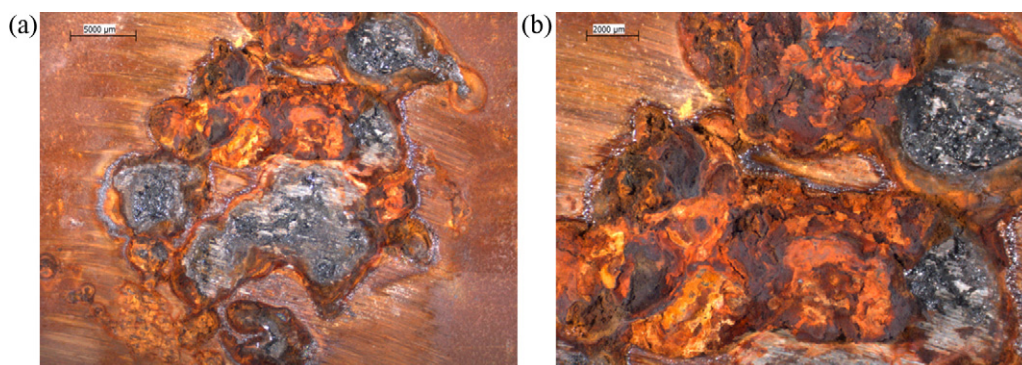
Tubercles of a corrosion product were detected only after 36 months of service on the surface of a horizontal multi-pass shell-and-tube type heat exchanger in the tube-side, i.e., in contact with fresh water originating from a cooling tower. The inlet temperature of the water was 45 °C, whereas at the outlet end the water temperature was about 75 °C. The heat exchanger was made of stainless steel of the type 304, EN 1.4301, with material analysis given in Table 1. The specimens for the present investigation included samples with evident corrosion product tubercles on the surface (Fig. 1a–b) and samples without apparent tubercles. The specimens were cut from neighbouring areas of the damaged

heat exchanger exposed to similar operating conditions. After cutting, a detailed visual examination revealed that in one of the specimens with corrosion tubercles corrosion damage had penetrated the entire wall thickness, 6.2 mm. However, in most of the cases, corrosion had reached only the depth of 2–4 mm. Tubercles occurred randomly on the surface of the heat exchanger shell, i.e., both on the uniform areas of the surface as well as on the corner welds.

Fig. 1. Stereomicroscopy images of the corrosion product tubercles on the heat exchanger surface. (a) A general view of the tubercle area. (b) A detailed view of the tubercle.
